Company name	Kansai EPCO
Date of occurrence	25.September.2007
Unit name	Mihama 2
Event	Flaws Found in Steam Generator A Reactor Coolant Inlet Nozzle Weld
International Nuclear Event Scale (INES)	0
Status of report	Final report

# Status of Mihama Unit 2 planned outage (Cause and Countermeasures of the Flaw in Steam Generator A Reactor Coolant Inlet Nozzle Weld portion)

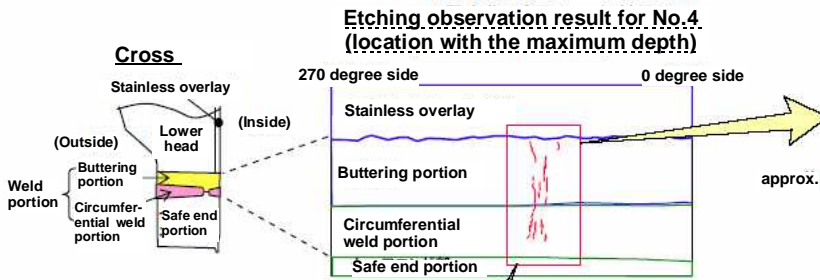
### Observation results for the weld portion

- Cracking No.4 consisted of multiple cracks of approx. 17 mm overall length on the surface, had the maximum depth of approx. 11.5 mm, which crossed most of the buttering portion and the circumferential weld portion, and propagated along the dendrite boundary. However, it did not reach the low alloy steel and the stainless overlay portion. For the safe end (SUS316 base metal) side, verification was not possible because of the notch introduced to open the fracture. As a result of SEM observation, fracture along the dendrite boundary was observed in the buttering portion and the circumferential weld portion.

- Multiple cracks of approx. 3 to 5 mm length existed intermittently in longitudinal direction.
- Cracking was along dendrite boundary in the weld portion.

The portion cut out will be recovered using 690 series Ni base alloy weld which has better corrosion resistivity. In addition, for caution's sake, a buffing finish will be applied in order to reduce residual stress in the affected portion.

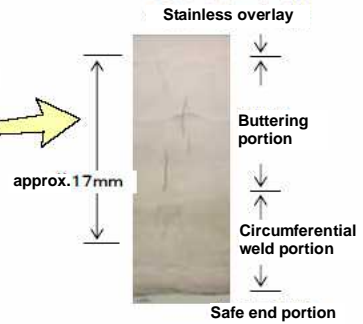
### SUMP observation results

- The cracking was found in the circumferential weld and battering portion, but not reaching the safe end and the stainless overlay portion. The cracking was an associate of multiple cracking having approx. 3~5 mm length in the axial direction, and the overall length was approx. 17 mm with the maximum opening width of approx. 30  $\mu\text{m}$ .
- The cracking was along the boundary of dendrite (column like shaped crystal made in melted metal while being cooled).
- In the battering portion, three layers of weld metal were identified. Also in the circumferential weld two beads of TIG weld metal were identified. Any clear trace of rewelding was not found in the battering portion and the weld portion.
- Any ductile cracking, fatigue cracking or corrosion was not found. Also it was verified that the flaw was not caused from a weld defect such as blow hole etc.

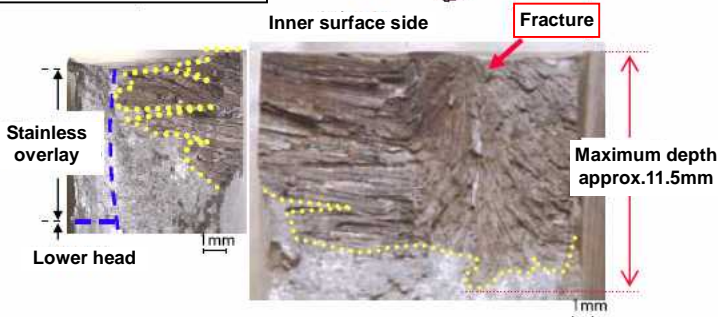
### Fracture observation

- Maximum depth of approx. 11.5 mm, developing along dendrite boundary.

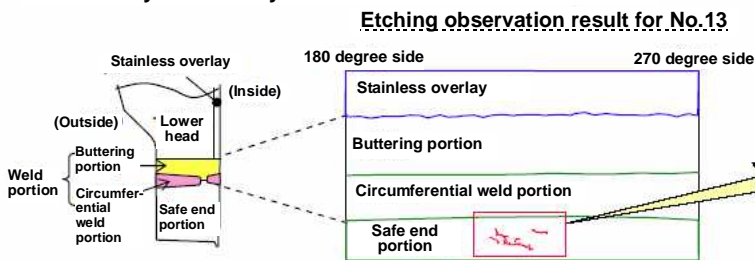
### Safe end observation result

Among the 13 locations found with significant signal indication for the S/G-A inlet nozzle, the No.13 indication found in the safe end was observed for its metal texture by SUMP and etching, and cracking in the safe end (SUS316 base metal) was identified at approx. 3 mm from the boundary with the circumferential weld. This cracking was multiple cracks with branching along the grain boundaries.

- Multiple cracking was found with branching along grain boundary of metal crystal.

The safe end portion (SUS316 base metal) will be replaced with a new one and finished with buffing. Further, a study on cracking generation in the safe end will be performed to enhance relevant knowledge.

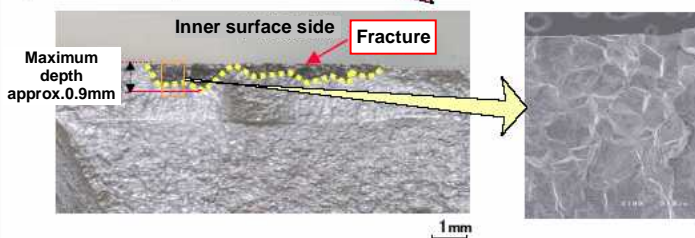
### Fracture observation

maximum depth of approx. 0.9 mm, and the other with approx. 4 mm surface length had the maximum depth of approx. 0.7 mm. Further as a result of the fracture SEM observation, fracture along the austenite grain boundary(\*7) was identified.

- Maximum depth was approx. 0.9 mm, developing along austenite crystal grain boundary.
