Company name	Kansai EPCO
Date of occurrence	04.December.2007
Unit name	Takahama 2
Event	Confirmation of the Flaws at the Inlet Nozzle Weld of Steam Generator B
International Nuclear Event Scale (INES)	0
Status of report	Interim report
Status when event occurred	
<p>During the 24th periodic inspection of Takahama Unit-2, eddy current tests (ECT)*1 for the inner surface of the inlet nozzle weld of steam generators (SG) A, B, and C were performed from November 25, 2007 until December 3, 2007 as a feed-back of Mihama Unit-2 where some damage was found at the steam generator inlet nozzle weld (600 nickel base alloy is used). The ECTs identified significant signal indications at the inlet nozzle weld of each steam generator, three (3) for SG-A (maximum length: 7 mm), two (2) for SG-B (max. length: 7 mm) and four (4) for SG-C (max. length: 14 mm).</p> <p>The ultrasonic tests (UT)*2 were conducted to confirm the flaw depth for nine points on the inlet nozzle weld of steam generator A,B, and C which showed significant signal indication in the ECT. The maximum depth of the flaw was confirmed to be about 8 mm (the thickness of the nozzle is about 79 mm) which was evaluated to fall well below

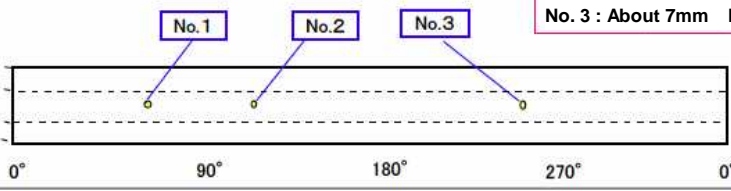
### ECT Results (Significant Indication)

Length	Depth
No. 1 : About 6mm	Not Detectable
No. 2 : About 6mm	Not Detectable
No. 3 : About 7mm	Not Detectable

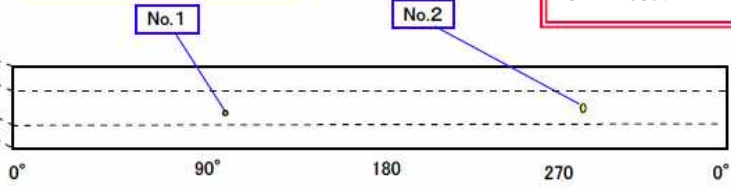
### ECT Results (Significant Indication)

Length	Depth
No. 1 : About 5mm	Not Detectable
No. 2 : About 7mm	About 6mm

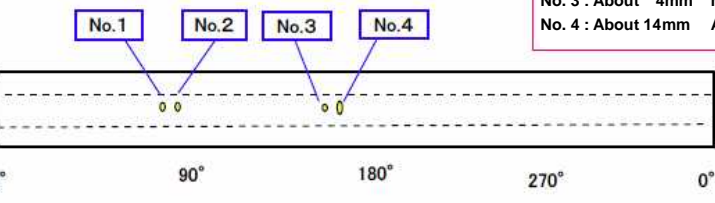
### ECT Results (Significant Indication)

Length	Depth
No. 1 : About 9mm	About 6mm
No. 2 : About 8mm	Not Detectable
No. 3 : About 4mm	Not Detectable
No. 4 : About 14mm	About 8mm
