Company name	Kansai EPCO
Date of occurrence	4, February, 2008
Unit name	Takahama 3
Event	Confirmation of Flaws at the Welds of Primary Coolant Inlet Nozzle of Steam Generators
International Nuclear Event Scale (INES)	0
Status of report	Interim report

# Takahama Power Station Unit 3 Flaws at Inlet Nozzle Welds of Steam Generators

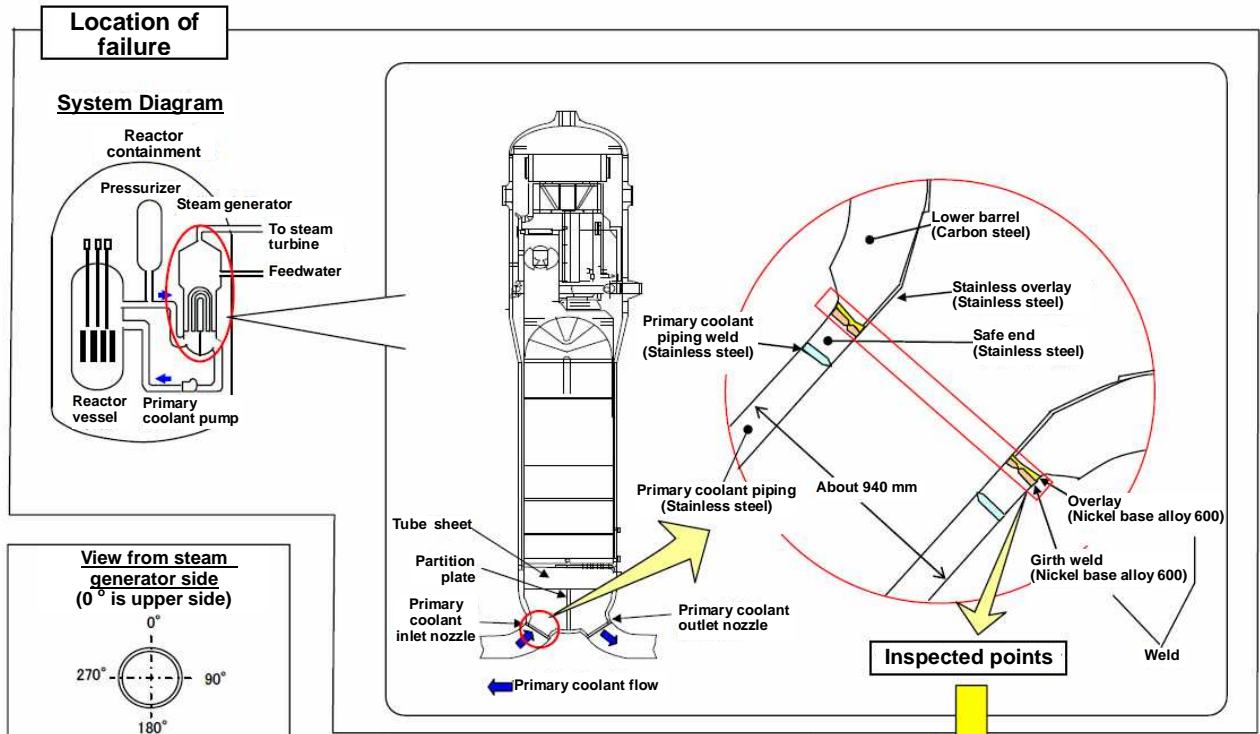
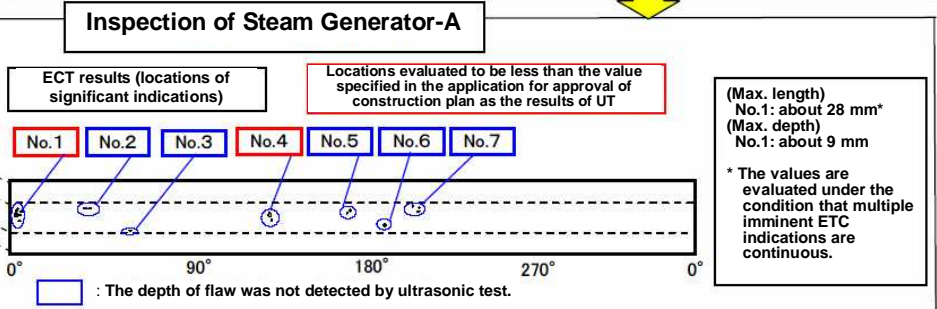
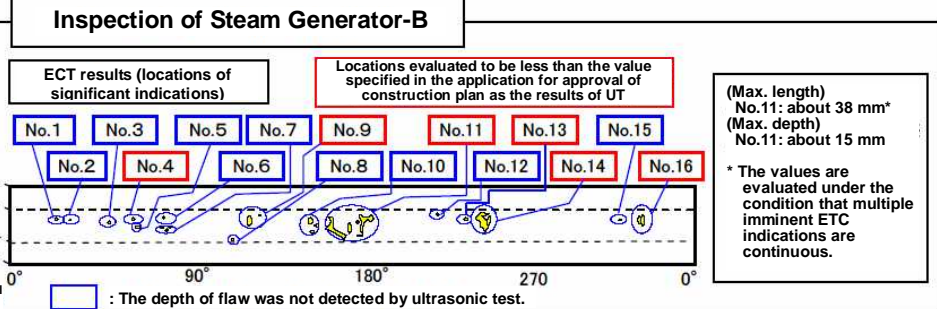
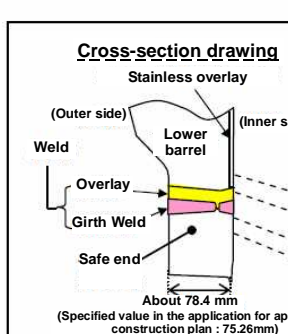
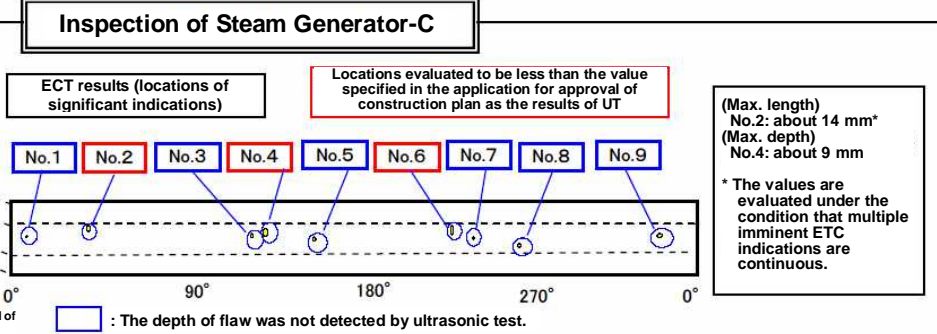
When the eddy current test (hereafter referred to as "ECT")\*2 was conducted on the inner surface of the relevant welds in advance from January 12 to 25 for preparation of this work, significant indications were identified at the inlet nozzle weld of each steam generator, i.e., 7 for SG-A (maximum length: about 28 mm), 16 for SG-B (maximum length: about 38 mm), and 9 for SG-C (maximum length: about 14 mm) (Multiple imminent indications were evaluated to be continuous.).

In order to identify the depth of flaw, the ultrasonic test (hereafter referred to as "UT")\*3 was conducted for 32 locations in the SG inlet nozzle welds, where significant indications were identified by the ECT. As a result of the UT, it was evaluated that the wall thicknesses of 11 locations of the inlet nozzle weld of SGs in total, i.e., 2 for SG-A (maximum depth: about 9 mm), 6 for SG-B (maximum depth: about 15 mm), and 3 for SG-C (maximum depth: about 9 mm), were less than 75.26 mm which is specified in the application of approval for construction plan subject to the Electric Utility Industry Law.
