| Company name | Kyushu EPCO |
| Unit name | Genkai 1 |
| Event | Inspection of the Inner Surfaces of Welded Locations of the Primary Coolant Outlet and Inlet Nozzles of Steam Generators |
| Status of report | Final report |

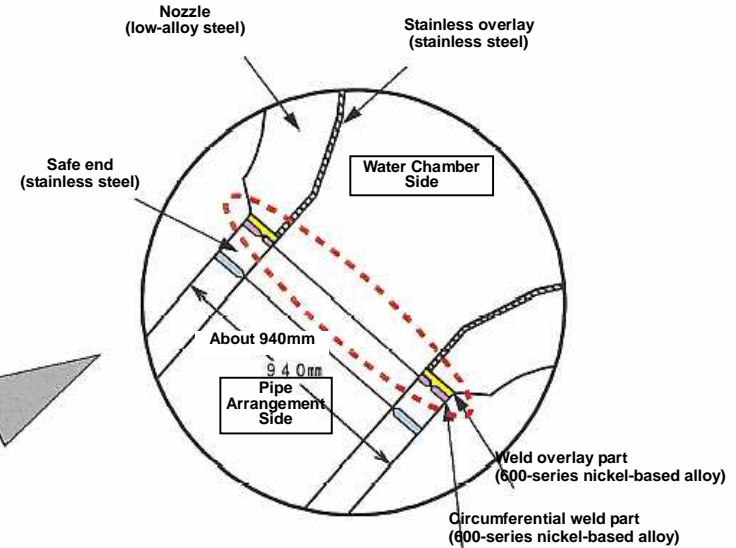
Locations Inspected

Angle measured in clockwise direction at 0° by seeing nozzle from water chamber

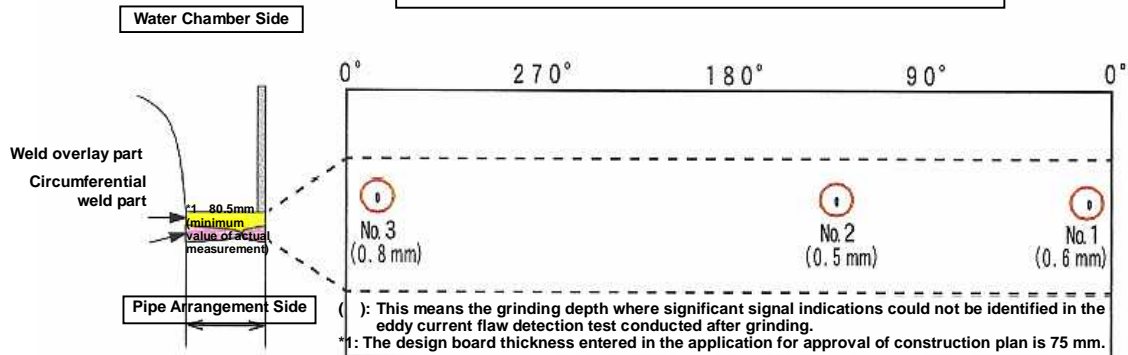
Results of Eddy Current Flaw Detection Test of Inlet Nozzle of A Steam Generator

| <p>1. Inspection results</p> <p>(1) ECT result</p> <p>Significant signal indication was found in the axial direction at three locations of the welded locations of the inlet nozzle of A-SG; locations at 9 degrees in circumferential direction (No.1), at 130 degrees (No.2) and 344 degrees (No.3). (Circumferential direction angle is measured setting the starting point (0 degrees) at the highest point of the nozzle, then going around clockwise viewing the nozzle from the water chamber.)</p> <p>(2) UT result</p> <p>UT was conducted for the parts showing significant signal indications in ECT of the welded locations of the inlet nozzle of A-SG. However, no significant signal indication was found nor was it estimated that the</p> | |

As for the three locations where significant signal indication was found in ECT results, grinding of 0.6 mm, 0.5 mm and 0.8 mm was performed at locations No.1, No.2 and No.3 respectively. ECT was conducted after the grinding and since no significant signal indication was found, it was concluded that the cracks were extremely shallow about 1 mm in depth. So as to assure the procedure, an additional grinding was performed to have sufficient margin in the detection accuracy of ECT.

As for cracks of the welded locations of the nozzle, it was confirmed through SUMP observation that the cracks have occurred along the dendrite border and have characteristics of stress corrosion cracking in the primary water environment (hereinafter referred to as "PWSCC").

It is assumed that PWSCC occurred due to the primary water environment and high stress from the high residual stress, which occurred on inner surfaces of the welded location, since machining (grinding) was conducted on the welded location of the inner nozzle welded with 600 type nickel alloy at the production phase of the replacement SG.

As for locations where significant signal indication was found in ECT, grinding was performed until no significant signal indication was found in ECT for the depth investigation and, furthermore, an additional grinding was conducted considering the investigation accuracy of ECT.

As a preventive maintenance measure, USP was applied to mitigate residual stress, which was planned to be conducted in this periodic inspection.
