Company name	Japan Atomic Power Company
Date of occurrence	18.October.2007
Unit name	Tsuruga 2
Event	Flaws Identified in the Steam Generator Reactor Coolant Inlet Nozzle Welds
International Nuclear Event Scale (INES)	0
Status of report	Final report

**Periodic inspection status at Tsuruga Unit 2  
(The cause and countermeasures of the flaws in the steam generator reactor coolant inlet nozzle welds)**

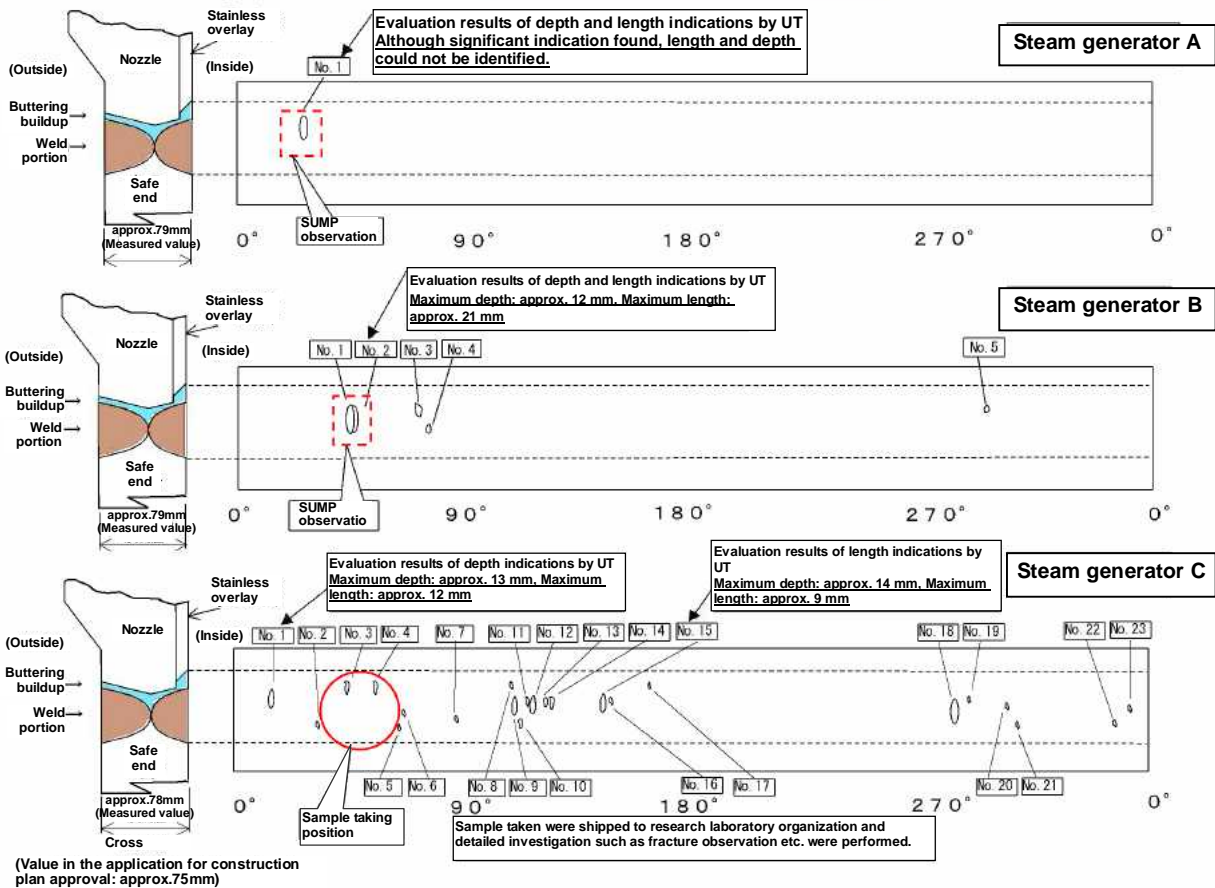
**ECT results (location with significant indication)**

Subsequently, the eddy current test of the inlet and outlet nozzle weld portion surface was performed for the other three steam generators, and thereby significant signal indication was identified at one location for the steam generator A inlet nozzle and at 23 locations for the steam generator C inlet nozzle. These significant signal indications were all identified in the circumferential weld portion.

Further, no of significant signal indication was identified in the steam generator D inlet nozzle. Also, for the outlet nozzles, no of significant signal indication was identified for any of the (A~D) steam generators.

For all of 29 locations where significant signal indication was identified by the eddy current test, the ultrasonic test was performed, and the locations where flaw depth was possible to be clearly identified were two locations in the steam generator B inlet nozzle and seven locations in the steam generator C inlet nozzle.

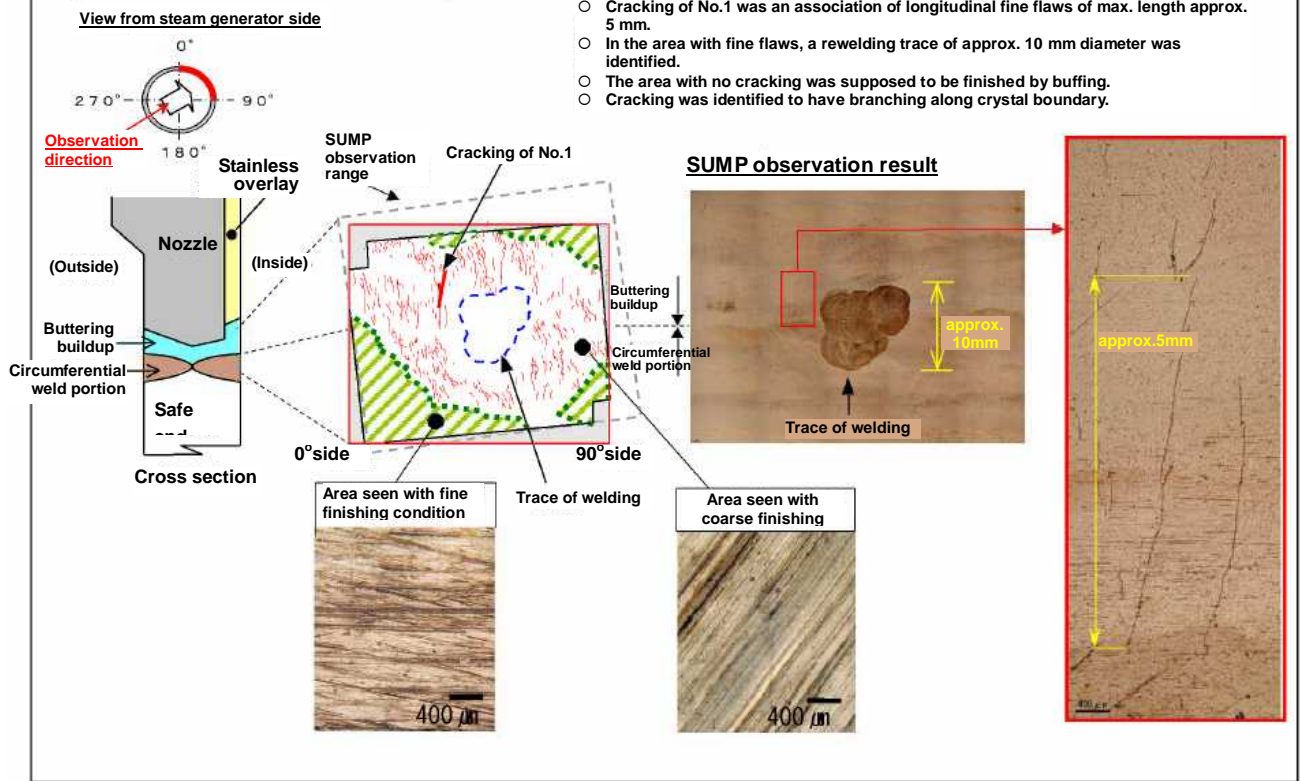
**Steam generator A cracking of No.1**

One location with significant signal indication was an association of longitudinal surface roughing (fine flaws).

Since the area having rough surface (fine flaws) is different in finished status indicating coarse finishing compared to that of the surrounding area, the rough surface was considered to be resulted from finishing by a grinder.

Further, the maximum length of surface roughing (fine flaw) was approx. 5 mm and the cracking was along the dendrite(\*10) boundary indicating the branching characteristic to PWSCC.

Since a trace of approx. 10 mm length thought to be that of rewelding was identified at the boundary of the inlet nozzle bevel buttering weld portion and the circumferential weld portion and the area around it was seen with coarse finishing, the affected portion was considered to be finished by a grinder after the rewelding.

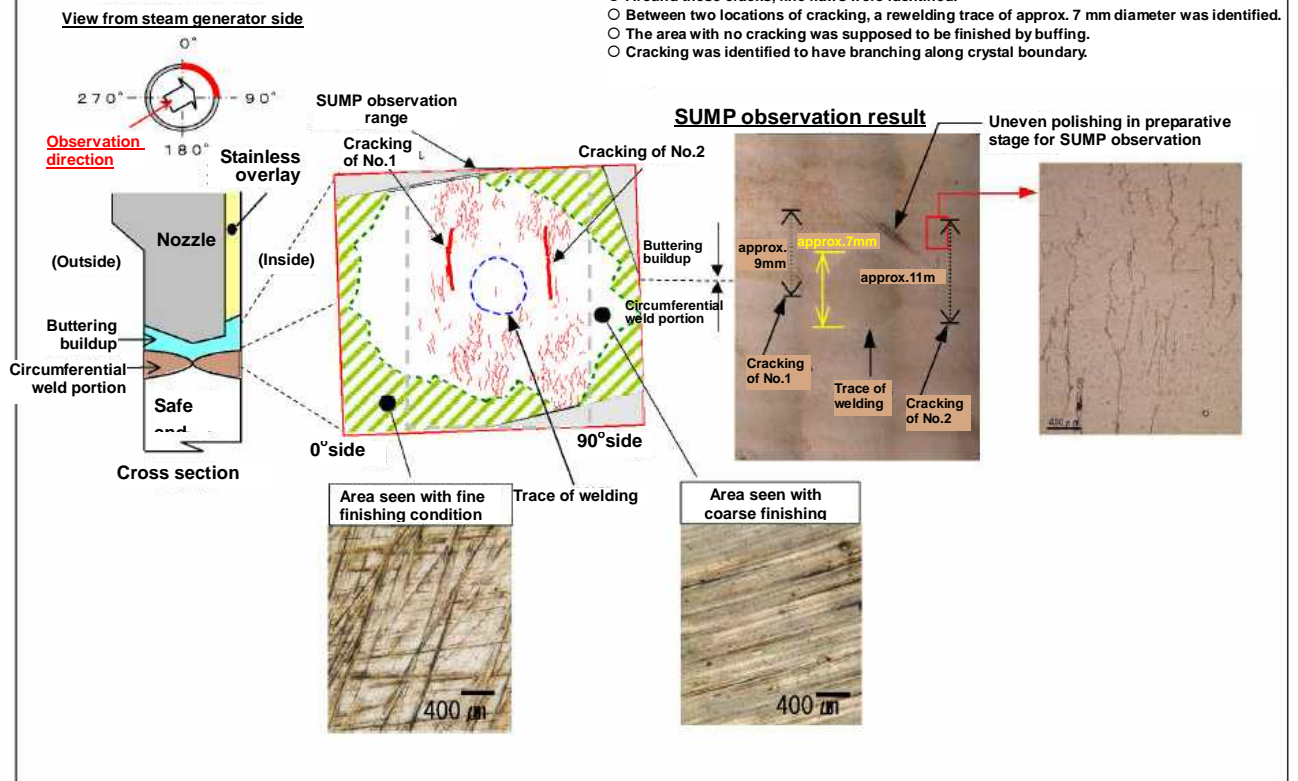
**Steam generator B cracking of No.1 and No.2**

For the signal indications of the two locations (No.1 and No.2) investigated this time, the signal indication of No.1 consisted of two circumferential cracks of approx. 4 mm and approx. 6 mm length with an overall length of approx. 9 mm. The signal indication of No.2 was a series of multiple longitudinal cracks of approx. 1 mm to approx. 4.5 mm length with an overall length of approx. 11 mm.

Around these cracks, multiple rough surfaces (fine flaws) were distributed.

The surrounding area with rough surface (fine flaws) was seen with coarse finishing, differing from the surrounding area without any rough surface, and therefore it was considered to be finished by a grinder.

The rough surface (fine flaw) was along the dendrite boundary and the branching characteristic to the PWSCC was identified.

Since a trace of approx. 7 mm diameter thought to be that of rewelding was identified at the boundary of the inlet nozzle bevel buttering weld portion and the circumferential weld portion and the area around it was seen with coarse finishing, the affected portion was considered to be finished by a grinder after the rewelding.

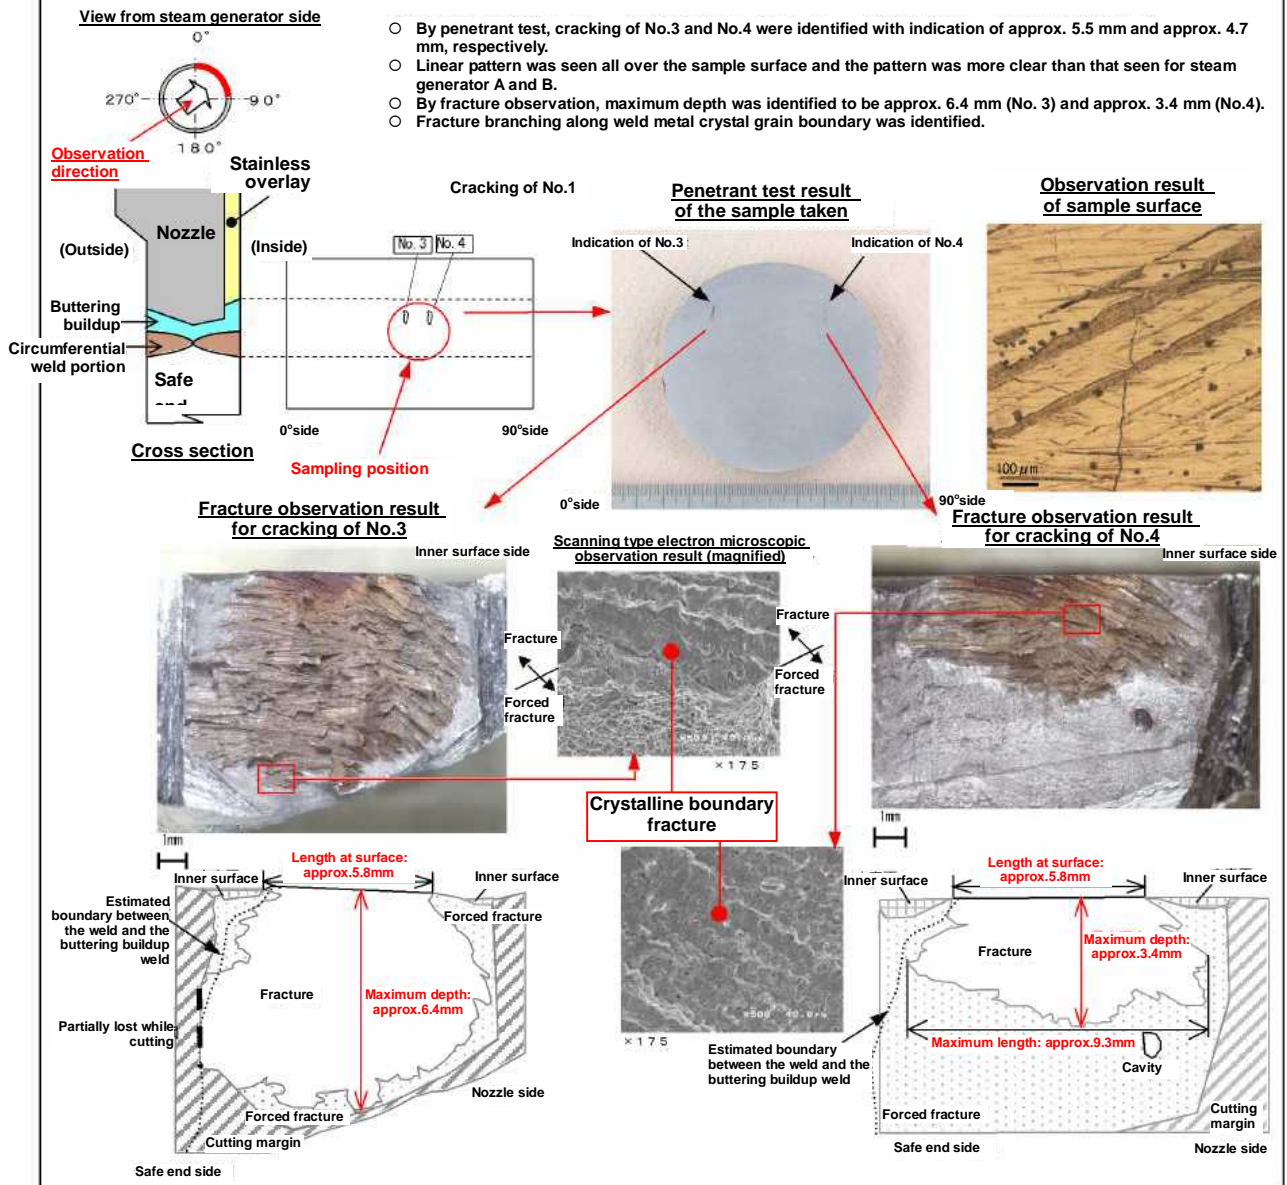
**Steam generator C cracking of No.3 and No.4**

The cracking of No.3 had a surface length of approx. 5.8 mm and the maximum depth of approx. 6.4 mm. The cracking of No.4 had a surface length of approx. 5.8 mm, the maximum depth of approx. 3.4 mm and the crack internal maximum length of approx. 9.3 mm.

Fracture along the dendrite boundary characteristic to the PWSCC was identified for both the No.3 and No.4 cracking.

- By penetrant test, cracking of No.3 and No.4 were identified with indication of approx. 5.5 mm and approx. 4.7 mm, respectively.
- Linear pattern was seen all over the sample surface and the pattern was more clear than that seen for steam generator A and B.
- By fracture observation, maximum depth was identified to be approx. 6.4 mm (No. 3) and approx. 3.4 mm (No.4).
- Fracture branching along weld metal crystal grain boundary was identified.

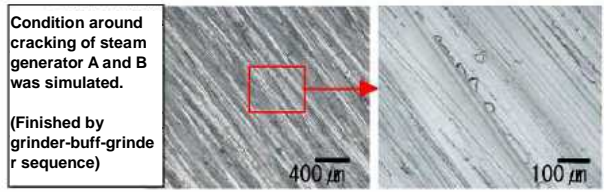
Approx. 470 MPa as average (Tensile stress)

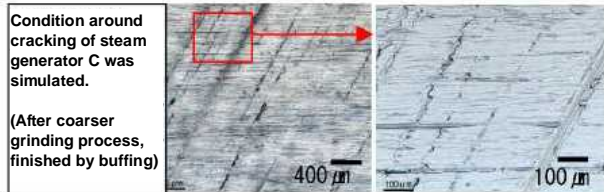
Approx. 210 MPa as average (Compressive stress)

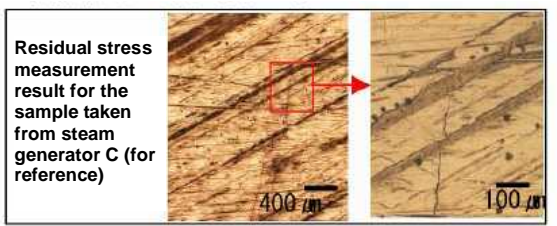
- Approx. 680 MPa difference exist between the surface processed by grinder and the surface additionally finished by buffing.
- In area of deeper grinding groove, residual stress at groove bottom is considered possible to be estimated by adding a correction of approx. 680 MPa to a general measured value.
- Adding 680 MPa to residual stress measured value for the sample taken from steam generator C, residual stress at grinding groove bottom was estimated at 90~420 MPa tensile.

263~591 MPa (Compressive stress)
