Company name	Hokkaido EPCO
Date of occurrence	April 9, 2008
Unit name	Tomari 2
Event	Confirmation of Flaws at Welded Part of Primary Coolant Inlet Nozzle of Steam Generator A and B
International Nuclear Event Scale (INES)	0
Status of report	Final report

## The Periodic Inspection Status of Tomari NPP Unit 2 Cause and Countermeasures for Flaws at Welded Part of Primary Coolant Inlet Nozzle of Steam Generator

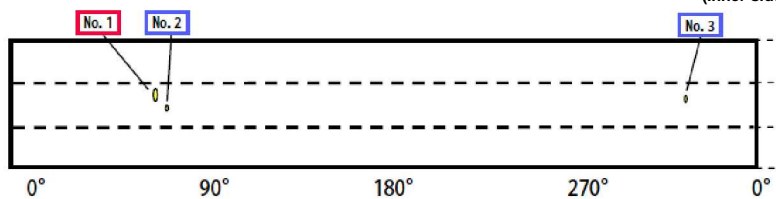
### Inspection Status of Steam Generator A

(Maximum length)  
No. 1: Approx. 13 mm\*  
(Maximum depth)  
No. 1: Approx. 7 mm

\*: The value was evaluated considering several adjacent ECT signal indications as a continuous flaw.

(The construction plan approval application registry value: 75 mm)

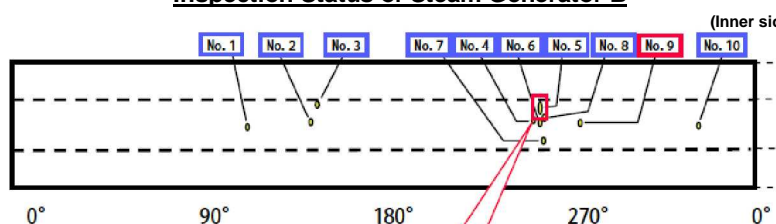
### Inspection Status of Steam Generator B

(Maximum length)  
No. 5: Approx. 10 mm\*  
(Maximum depth)  
No. 9: Approx. 5 mm

\*: The value was evaluated considering several adjacent ECT signal indications as a continuous flaw.

(The construction plan approval application registry value: 75 mm)

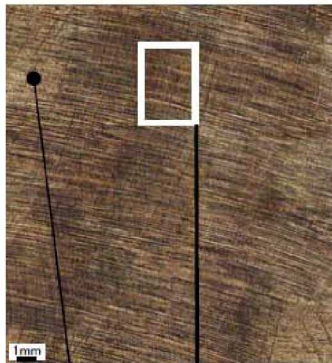
**Replica examination**

b. Traces of buff-finishing were observed above grinding work (grinding) at the whole area of the indicated part No. 5 of SG-B and traces of finishing work other than grinding work (polishing) were observed at the cracked part.

Traces of buffing work

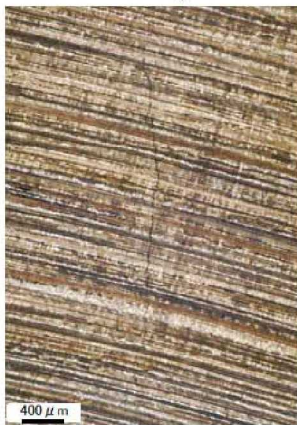
Finishing traces that are assumed to be of grinding work (polishing)

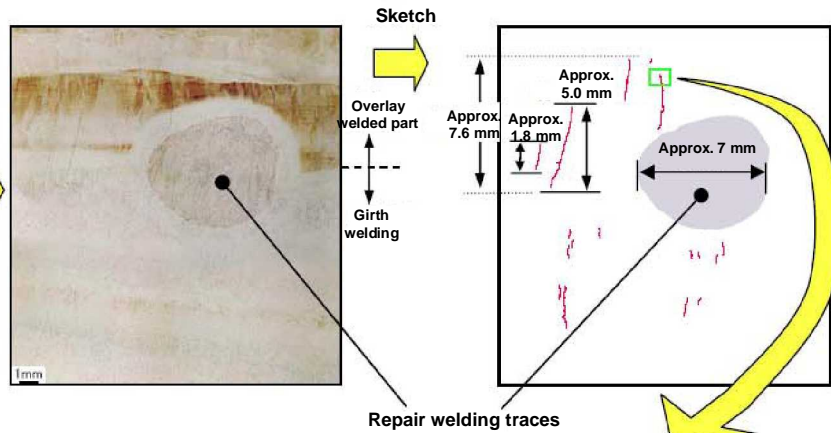
**SUMP observation result**

a. Cracks were found at girth weld area and overlay weld area of 600 type nickel base alloy and were not found at the safe-end of stainless steel and the stainless lining part of the inlet nozzle.

b. Cracks of approx. 1.8 mm to 5.0 mm in axial direction were found, where the whole length was approx. 7.6 mm.

c. Traces of repair welding of approx. 7 mm in diameter were found around the crack area.

d. The cracks have occurred along the dendrite border\*7 and a similar facet to that of primary coolant stress corrosion cracking\*8 (hereinafter referred to as "PWSCC") observed both domestically and internationally at welded area using 600 type nickel base alloy was found.

Cracks have occurred along the dendrite border that has a similar facet to that of stress corrosion cracking in the primary coolant environment.
