Post-quake status of the Kashiwazaki-Kariwa Nuclear Power Station (Report #11)
- Update on the status of inspection and restoration work through to November 8 -

November 12, 2007

Japan Nuclear Technology Institute

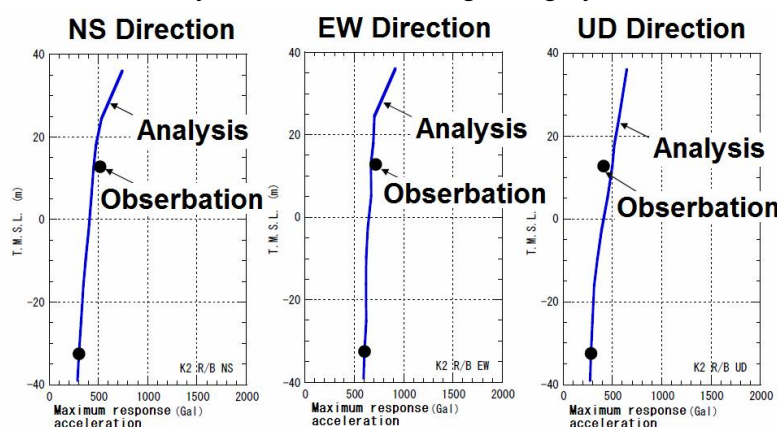
Fig. 1 Maximum response
Acceleration (Unit 2)
Source: Courtesy of the TEPCO

- i. The analysis that took actual earthquake conditions into account was able to reproduce the seismic observation records relatively well. (Figures 1 and 2 show the example of Unit 2, which suffered seismic motions that exceeded the level assumed at the time of plant designing most drastically.)
- ii. The maximum response shear strain, obtained in the analysis, indicates that the reactor buildings fall within the designed scope of resilience. (Figure 3 shows the example of Unit 2.)
- iii. The results are to be compared against the outcome of crack checks and other inspections currently underway to confirm the buildings' integrity.

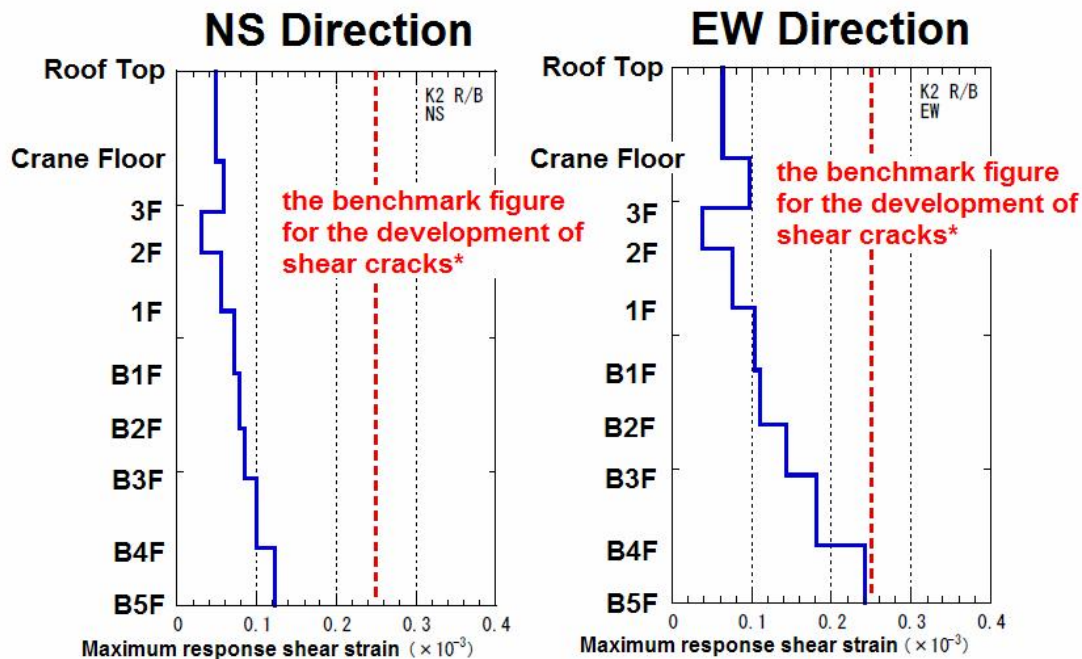
Fig. 3 Maximum response shear strain of the reactor building (Unit 2)

The conditions of the simulation were applied to calculate the maximum response shear strain of the reactor buildings, and the results for all the reactor buildings were below the benchmark figure for the development of shear cracks, indicating that the structures fell within the designed scope of resilience. WG members did not present any major arguments that deny the finding.

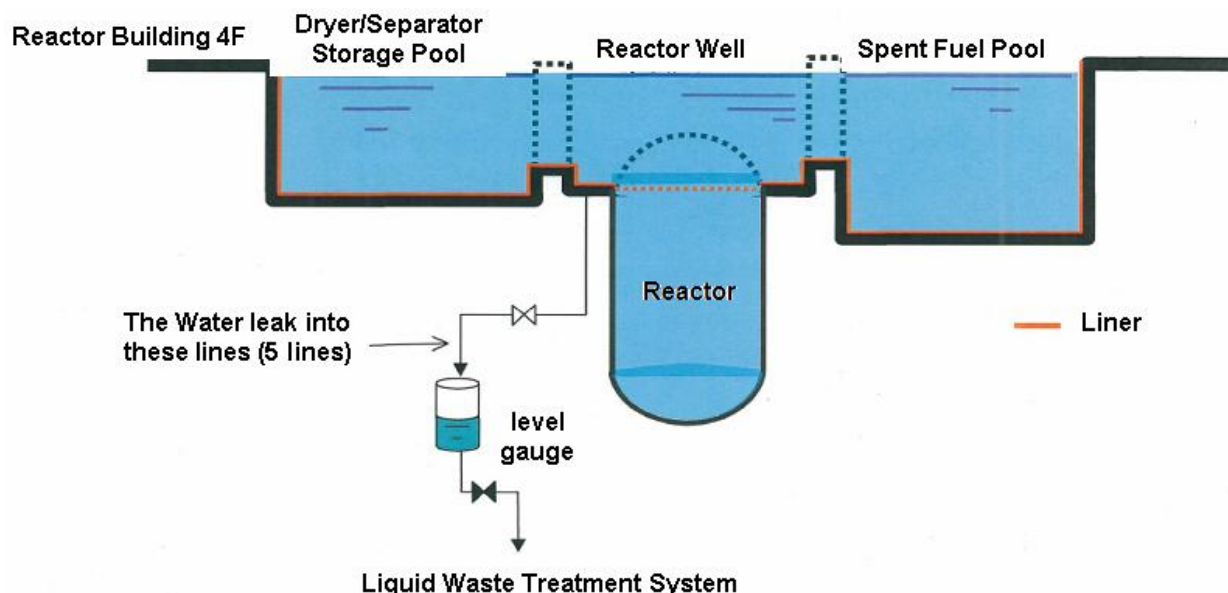
Layout of leakage detected system for unit 7 reactor well

TEPCO found some water inside a level gauge connected to the well liner, and conducted trend monitoring as well as analysis of the water itself, to detect a minute amount of radioactive material (antimony 124).

It is believed that some of the water used for filling the upper reactor flowed into the level gauge via the liner. (See the diagram below.)

This leakage did not cause any radioactive impact on the external environment.

The liner is currently being inspected, with minor damage that could lead to leakage identified in two locations. The damaged sections are to be temporarily repaired before an in-core inspection is conducted.

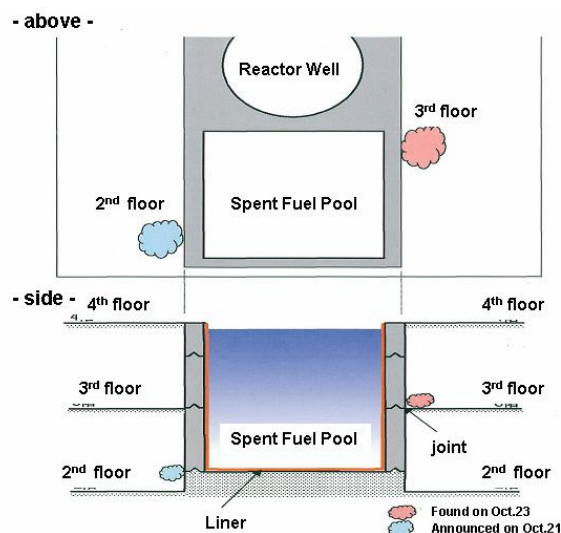
Water leak point at the Unit 7 reactor building

TEPCO identified water seepage from minor wall cracks and puddles of water on the floor in radiologically controlled areas on the 2nd floor of the reactor building. Analysis of the leaked water detected a minute amount of radioactive materials (cobalt-60 and cesium-137).

The amount of water leaked totaled 6.5 liters containing radioactivity of 250Bq, which is equivalent to radioactivity found in around 30cc of radon spa water.

Since the amount of leakage drops when the water level of the reactor well goes down, TEPCO suspects that the leakage came from the well. An investigation on the well will be conducted in the future ([See the attachment for a schedule of Well Inspection of Unit 7](#)) to identify the location of the leakage. (See the diagrams on the below.)

TEPCO also identified minute water seepage at a concrete joint on the north side of the reactor building's 3rd floor. Analysis of the water detected a minute amount of radioactive material (cobalt-60). The amount of water leaked totaled 200cc containing radioactivity of 0.8Bq, which is equivalent to radioactivity found in around 0.1cc of radon spa water. (See the diagram on the right.)

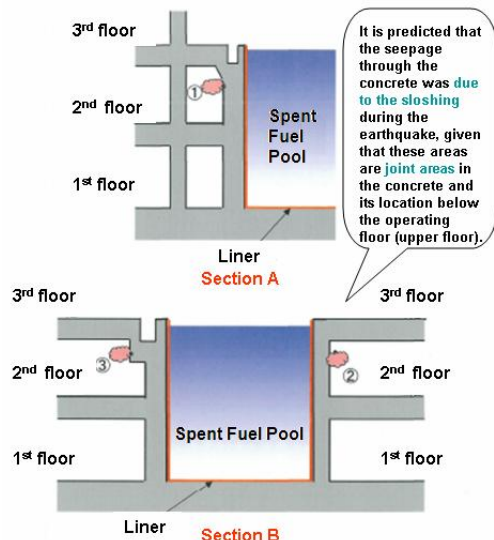
Seepage point at the Unit 1 reactor building

A minute amount of radioactive material was detected in the water, and TEPCO plans to continue monitoring the site. (See the diagram on the above. Source: Courtesy of the TEPCO)

At Unit 1, minor water seepage, suspected to be attributable to sloshing and resulting infiltration of overflowed water (See Report #4), was found on the concrete wall of the spent fuel pool at the lower part of the reactor operating floor.
