Post-quake status of the Kashiwazaki-Kariwa Nuclear Power Station (Report #13)

- Results and current status of reactor opening and in-core inspections -

Japan Nuclear Technology Institute
Rev.0
February 19, 2008

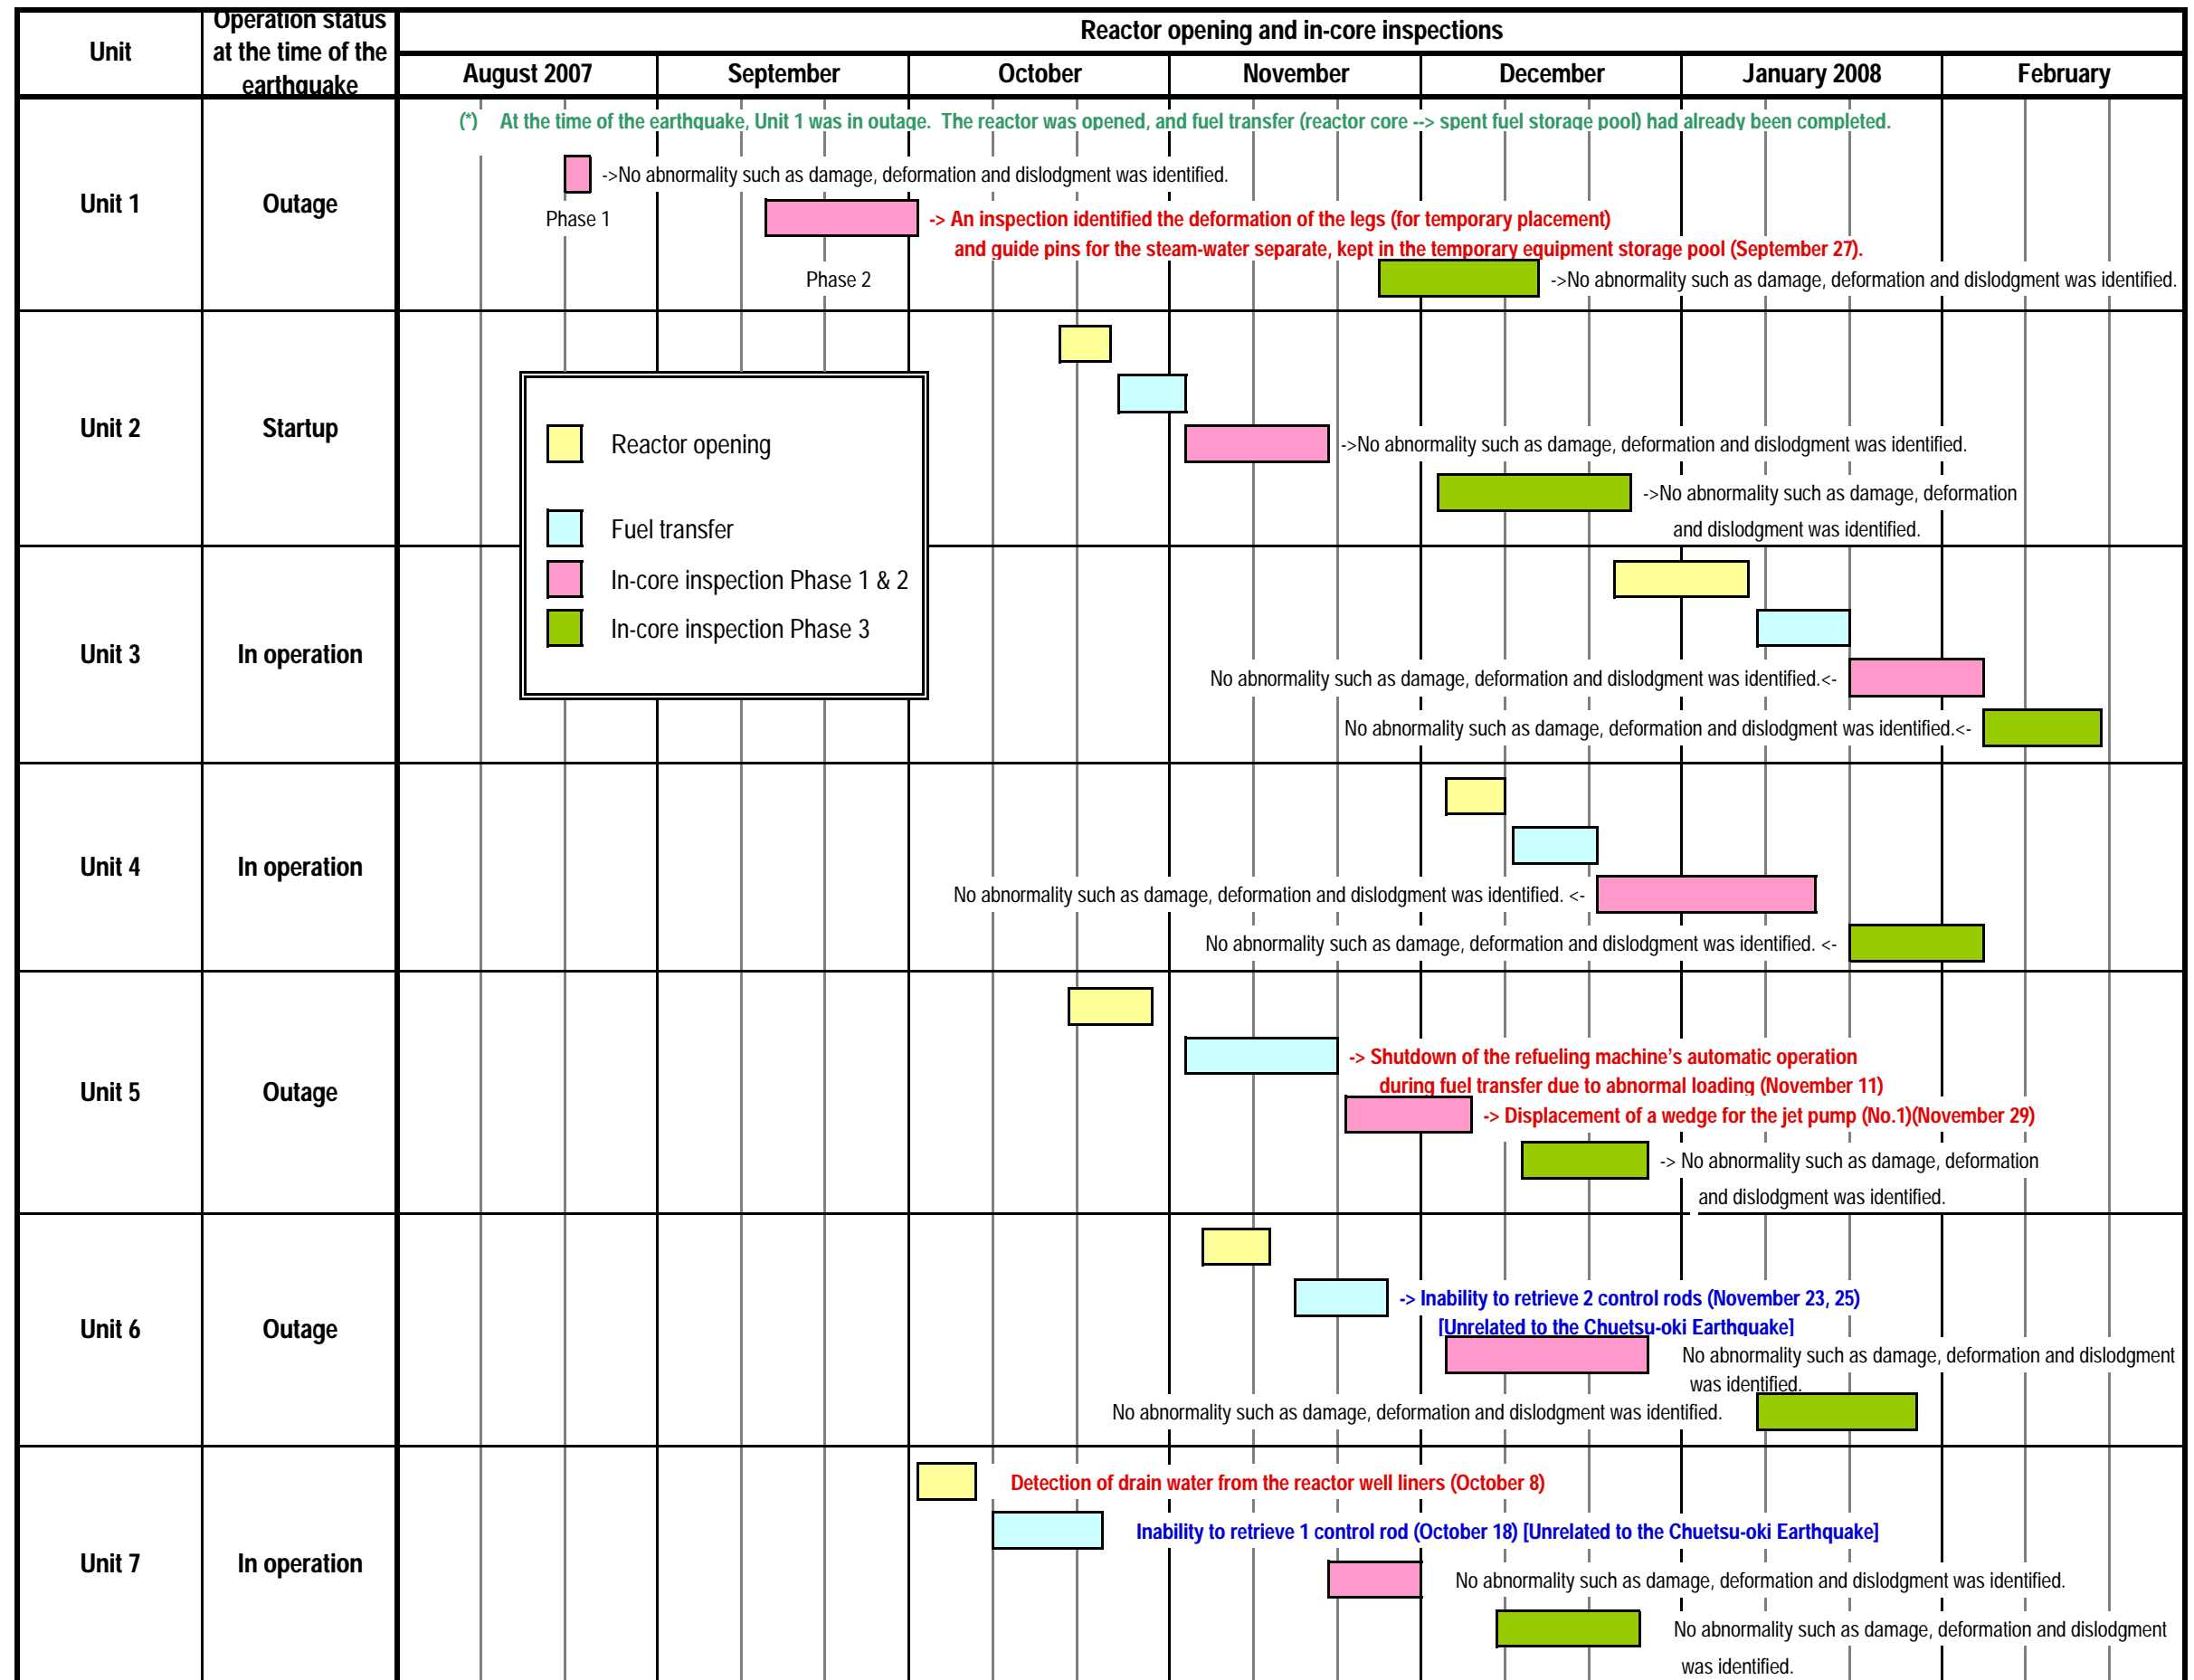
Outcome and status of reactor opening and in-core inspections at the Kashiwazaki Kariwa Nuclear Power Station

【Phase 1】 (Inspection of the upper reactor) : In order to check inside of the reactor core, first conduct visual inspection of the overall reactor core by an underwater camera from above, followed by inspection of an area covering from the reactor pressure vessel flange to the upper grid plate.

【Phase 2】 (Inspection of the mid-reactor (reactor core)) : Conduct visual inspection of the area covering from the upper grid plate to the core support plate and the outer circumference of the core shroud (annulus) usnig and underwater camera. Also inspect the dryer and separator that are taken out of the core.

【Phase 3】 (Inspection of the bottom reactor) : Inspect the area covering from the core support plate to the bottom of the reactor after moving control rods and fuel supports that interfere with the inspection.
