**Review of Accident at Tokyo Electric
Power Company Incorporated's
Fukushima Daiichi Nuclear Power
Station and Proposed Countermeasures
(Summary)**

October 2011

Japan Nuclear Technology Institute

Fukushima Daiichi Nuclear Power Station Accident Investigation and Review Committee

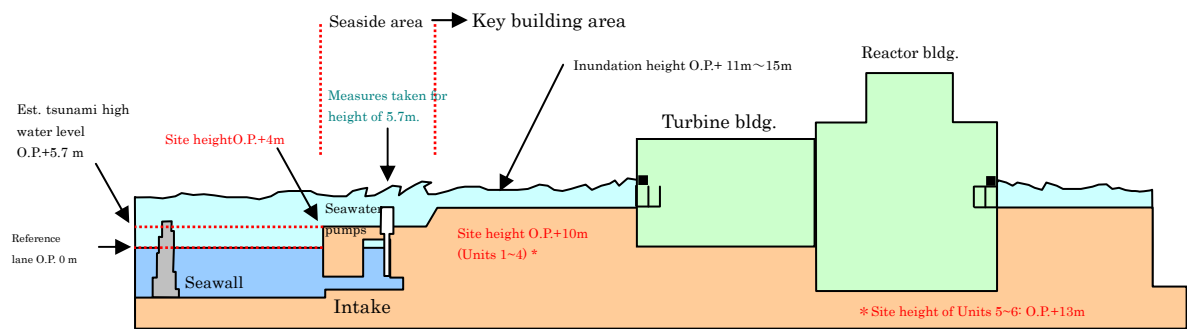
Tsunami Conditions

The height of the tsunami exceeded the water level designed for tsunami as shown in the diagram below, and almost the entire area around important buildings was inundated. Although there was no significant damage to the structural framework of key buildings, seawater flowed into the buildings through openings and other penetrations, and a broad expanse of the underground levels was also inundated through passageways, stairwells and other such routes.

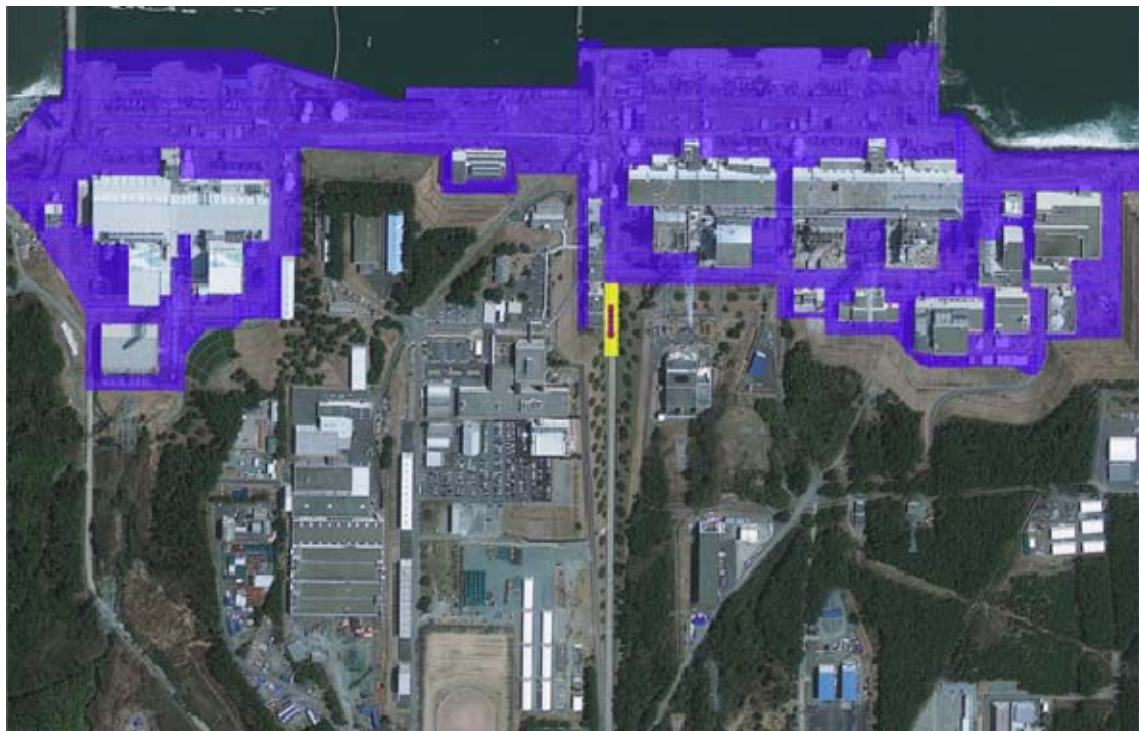
Scope of Inundation within Power Station (Purple area indicates seawater inundation and yellow area indicates a run-up point)

In addition, many of the emergency DGs and electric power panels which were installed on the lower levels of the reactor and turbine buildings were damaged by tsunami. With the exception of Unit 6, functionality of emergency power sources was lost.

Moreover, all seawater pumps for cooling were damaged by tsunami, and any means of releasing heat from the core or other areas into the sea were lost.

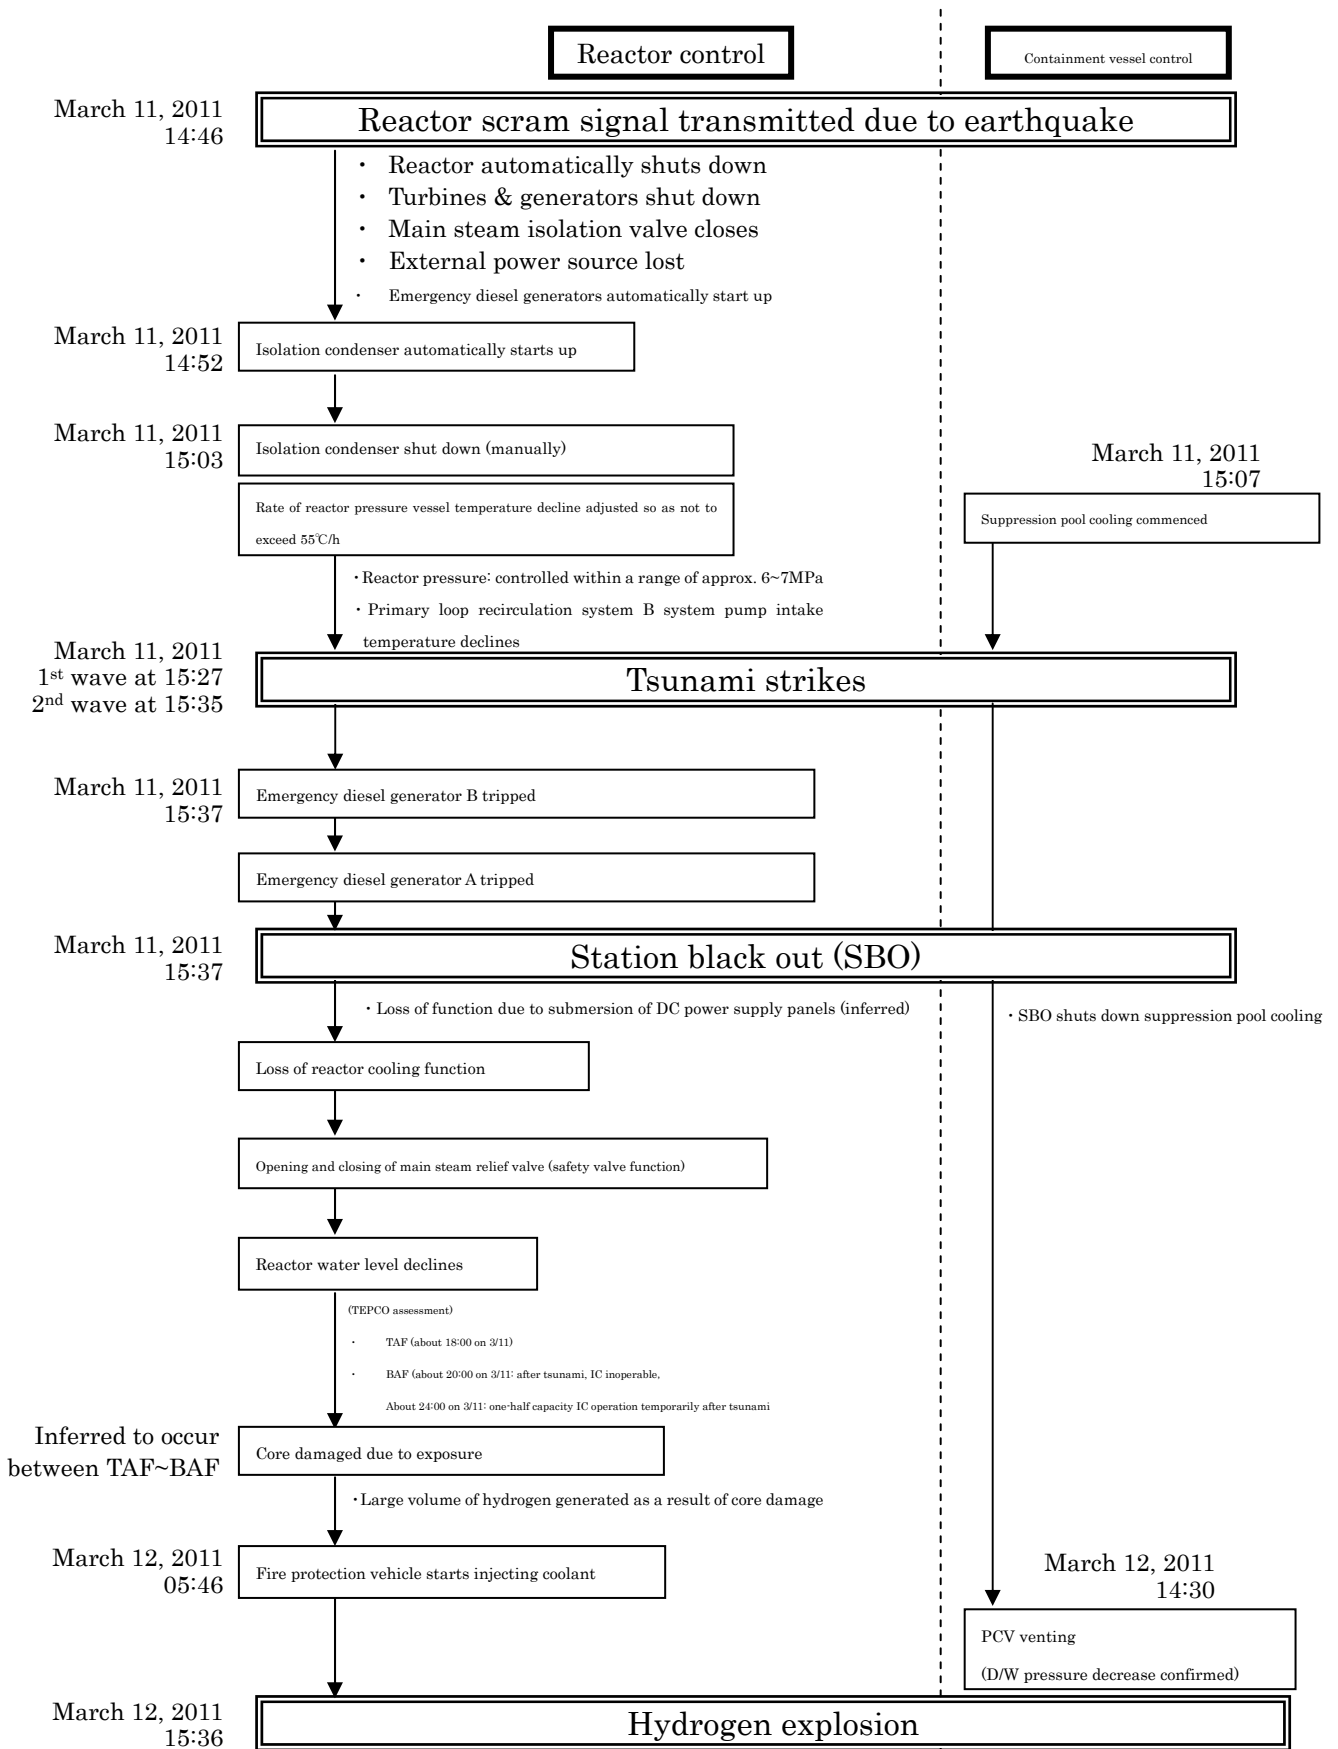
Diagram 2.1-1 Course of Accident Event Progression at Fukushima Daiichi Unit 1 Nuclear Power Station after Earthquake

The reactor at Unit 1 was cooled by the isolation condenser (“IC”) in accordance with the shutdown procedures and guided into a cold shutdown, but the tsunami caused a loss of emergency AC and DC power source functionality, and it is possible that most of the valves were in a closed state.

Consequently, it is inferred that the core was not cooled, became damaged and hydrogen was generated which leaked from the containment vessel to the reactor building, leading to the hydrogen explosion.

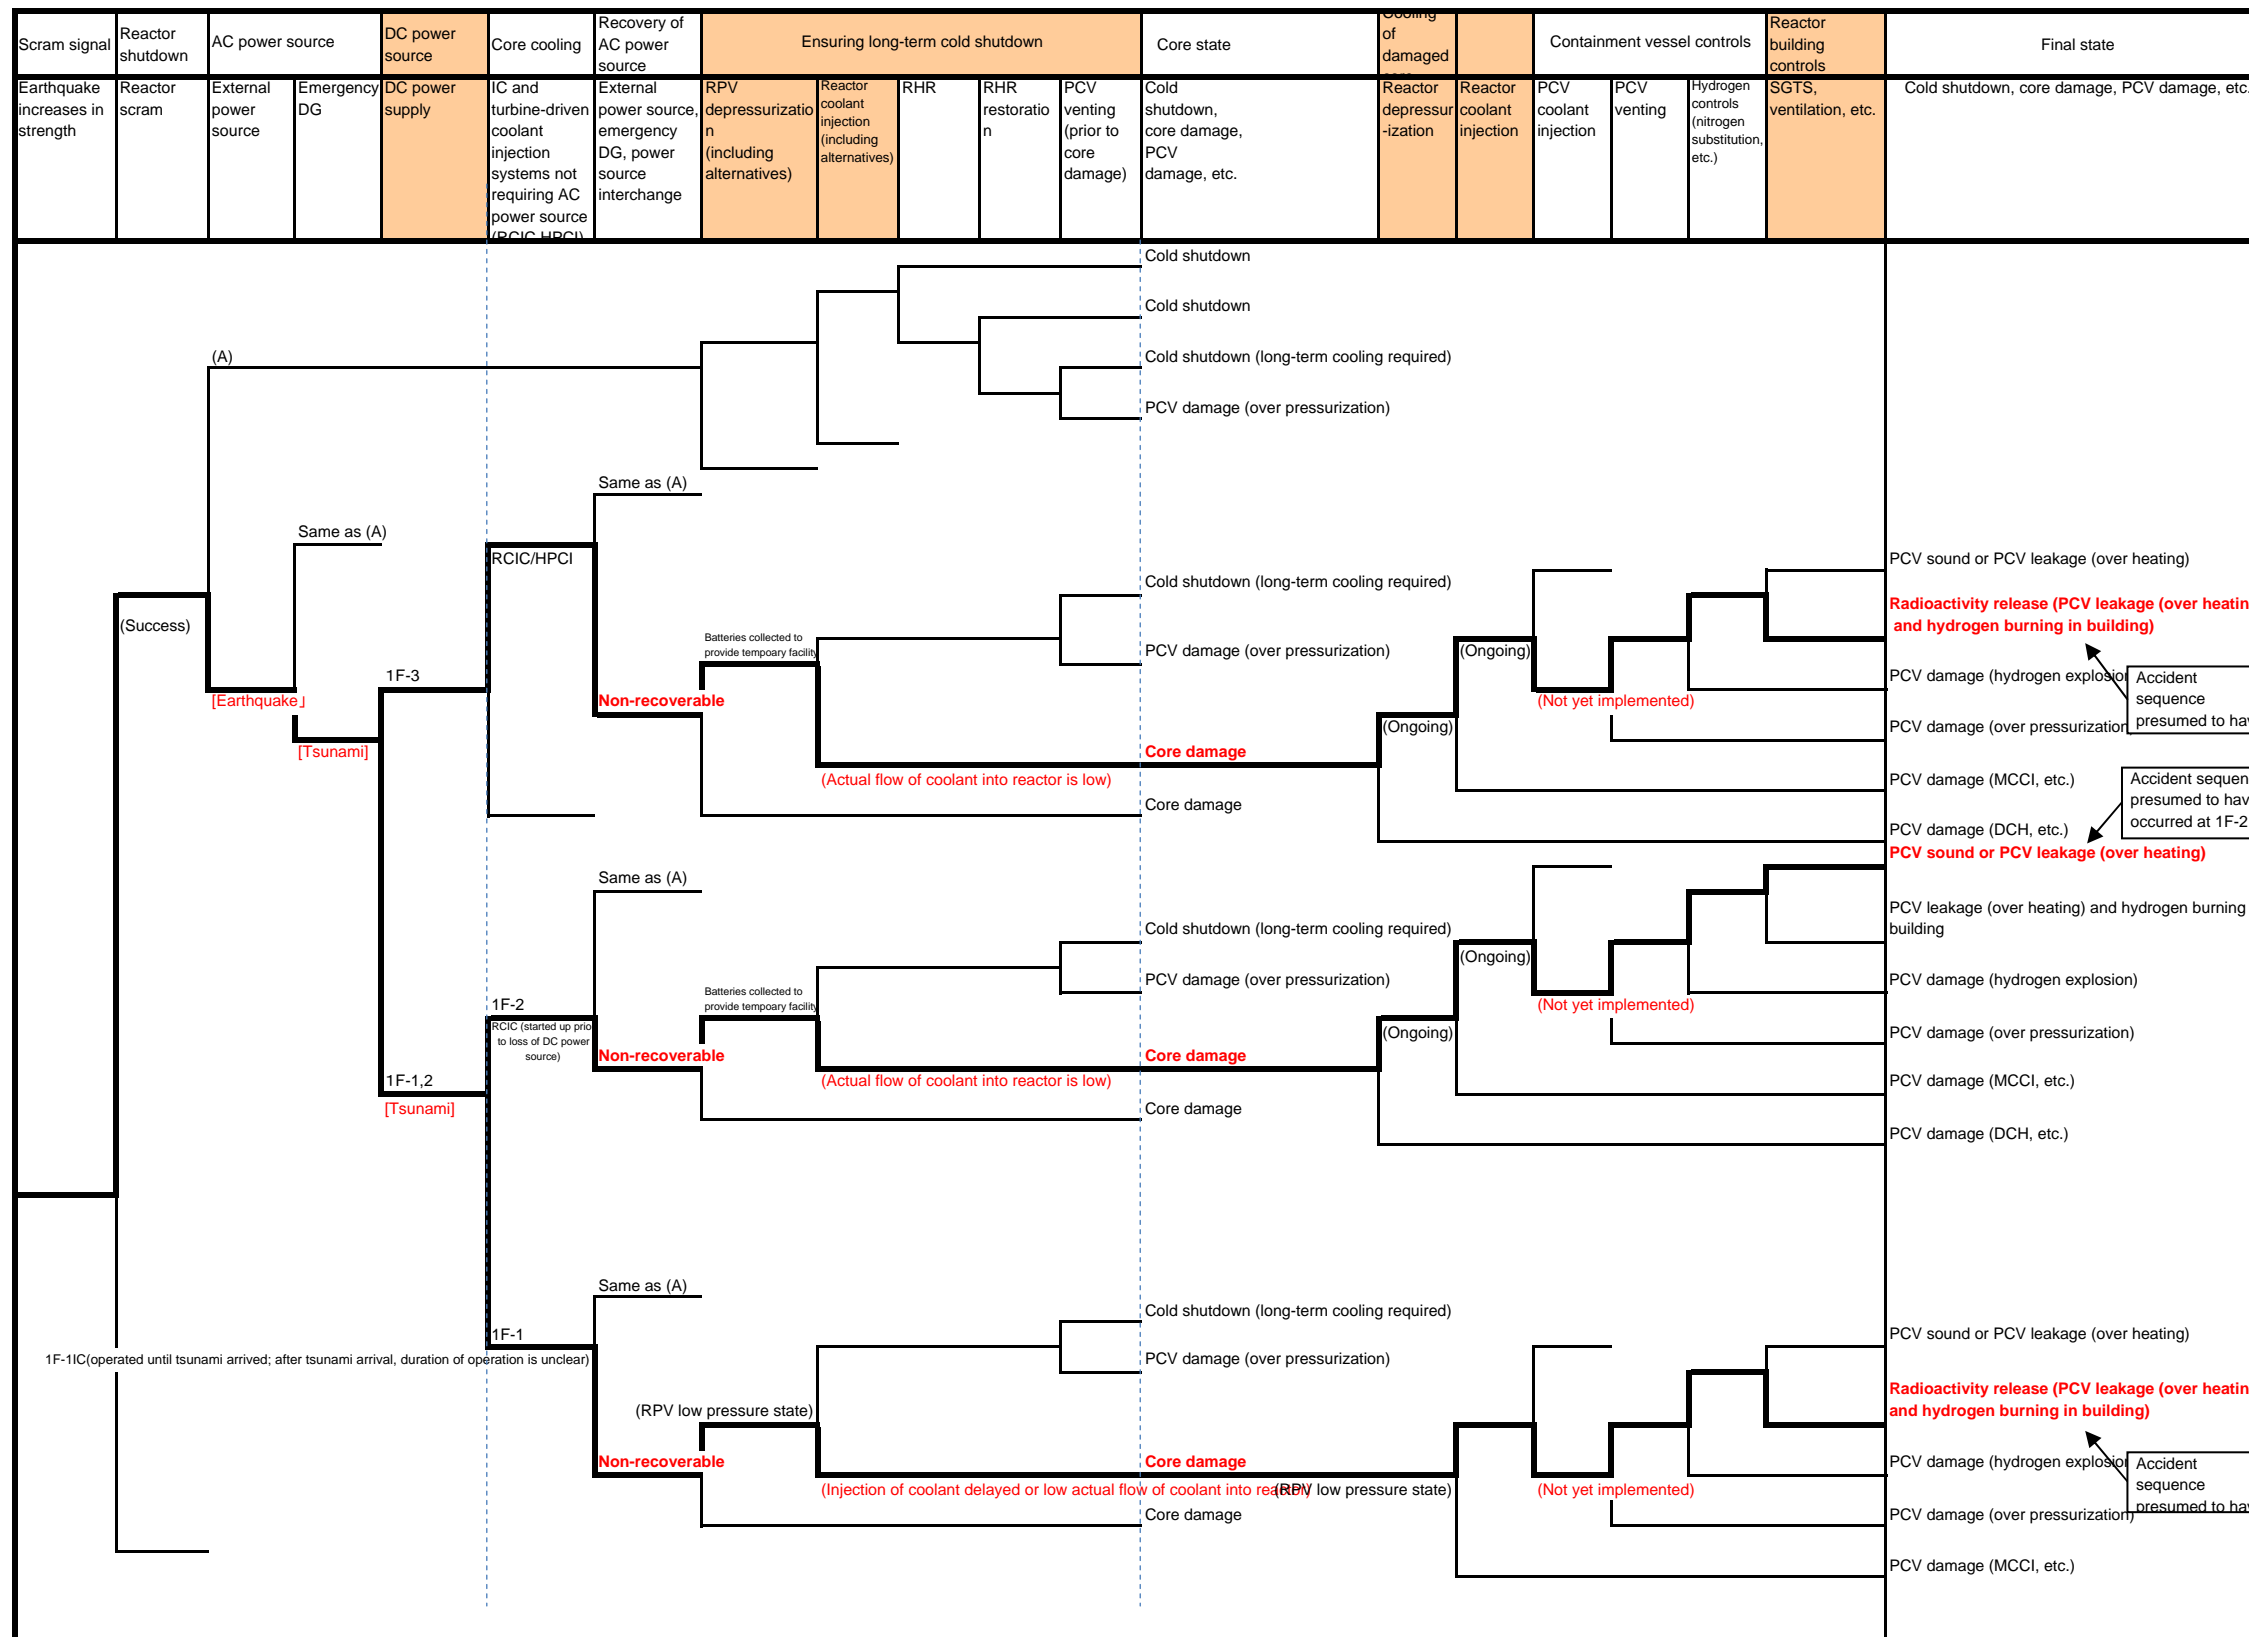
Diagram 2.1-1 Event Tree Showing Progression of Accident at Fukushima Nuclear Power Station Units 1~3

divaricating convergence and expansion of events have been arranged and consolidated into the event tree shown in Diagram 2.1-2.

The subsequent progression of events differs depending on (1) the circumstances entailed in loss of power source functions due to the earthquake and tsunami, (2) condition of core cooling function, and (3) success or failure of measures to mitigate events after core damage, as well as other factors.

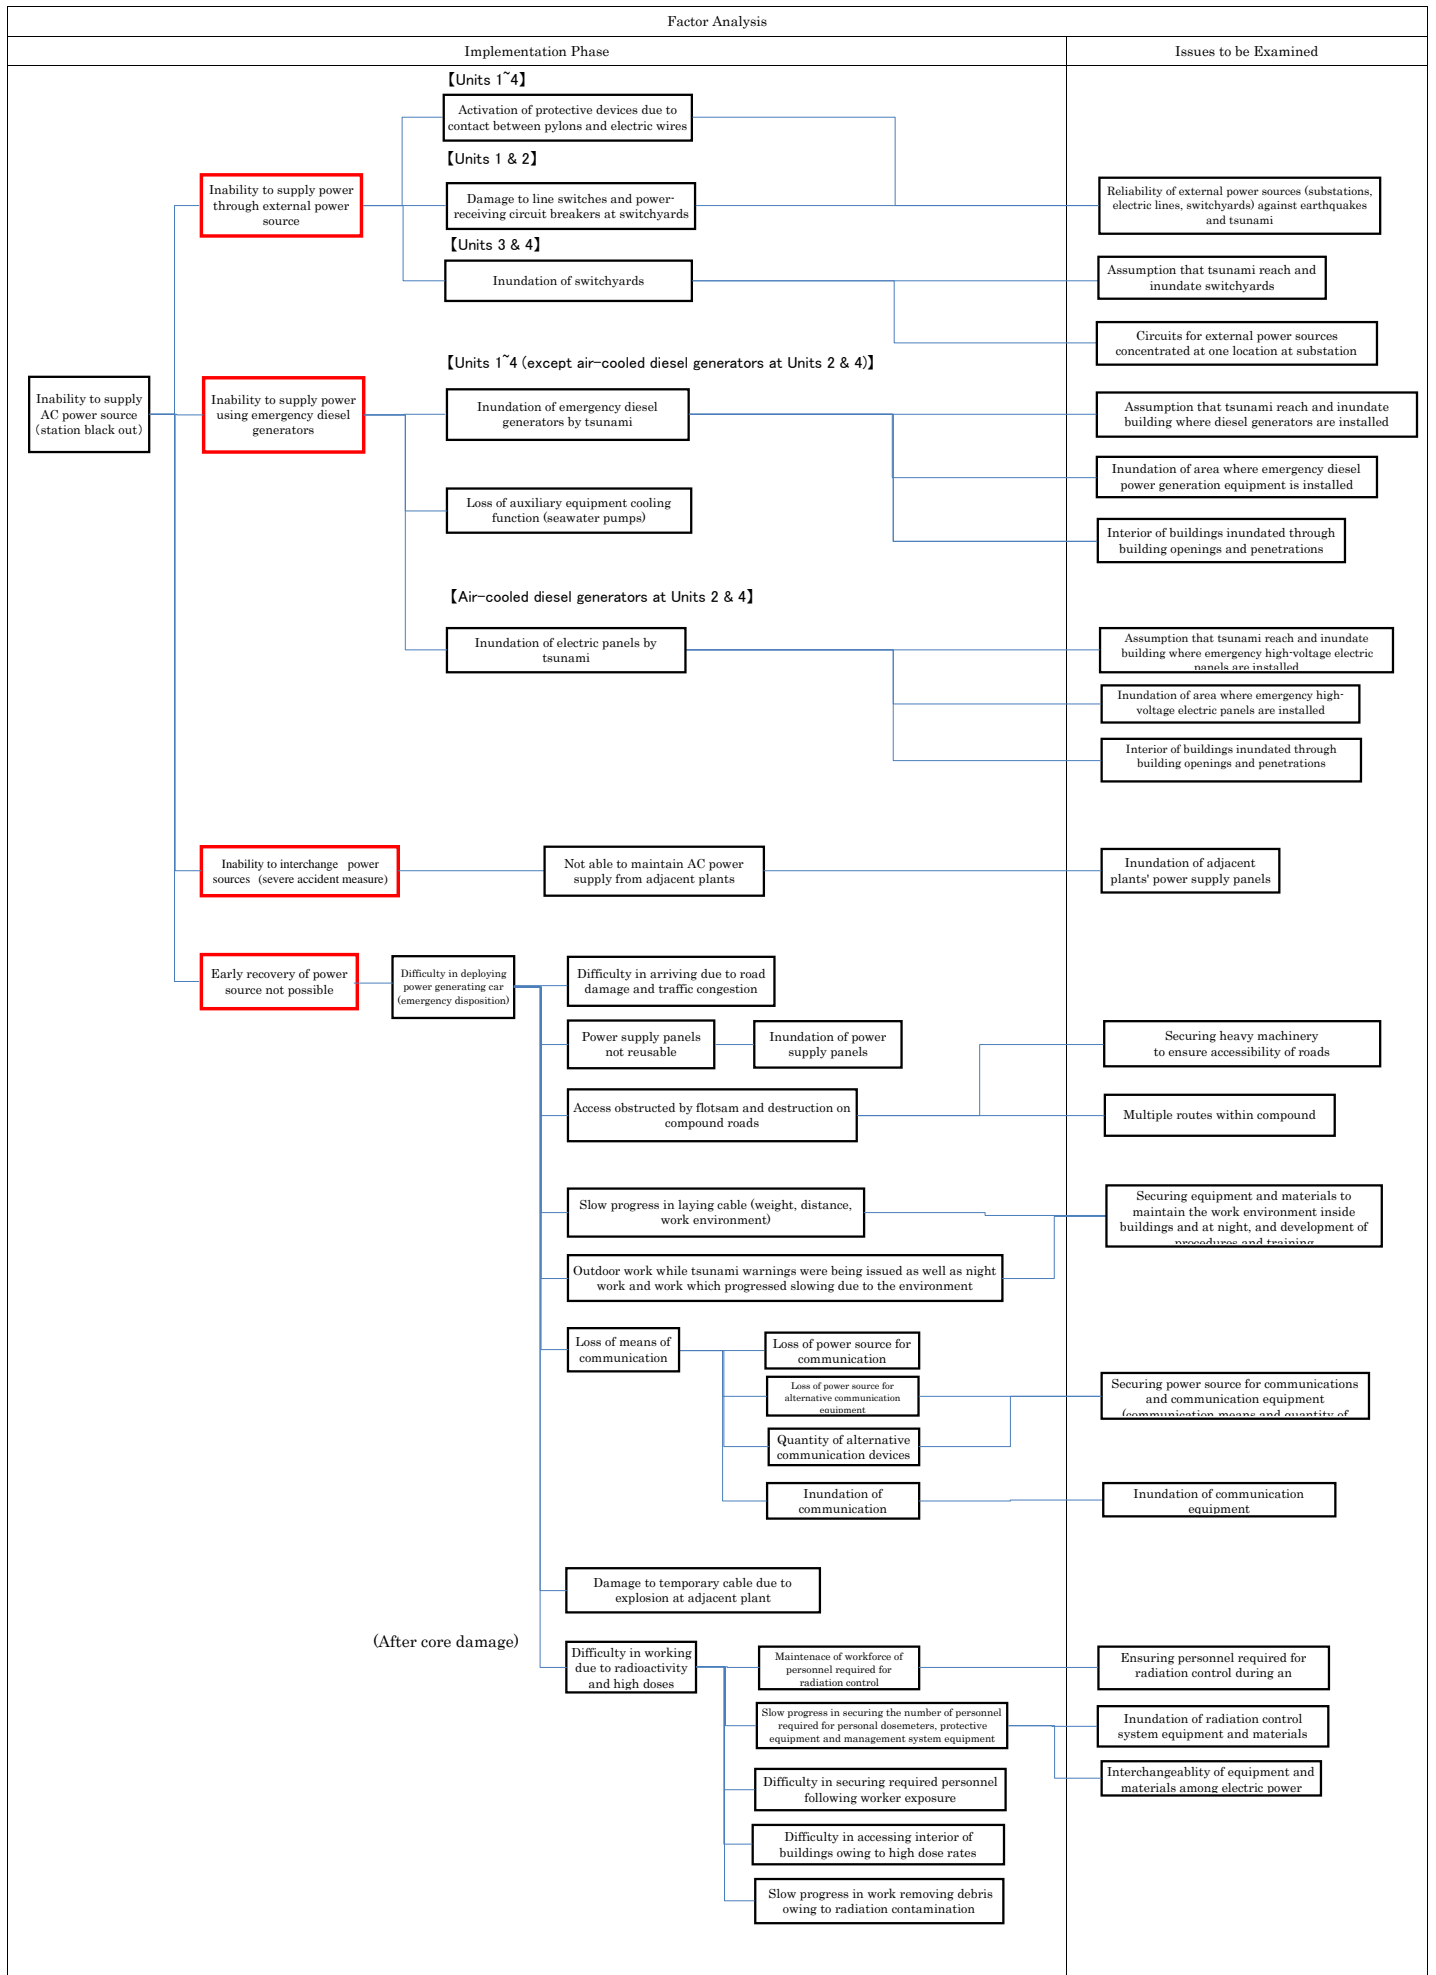
Diagram 2.2.1 Analysis of Factors Leading to Inability to Supply AC Power

The results of a factor analysis regarding the “inability to supply any AC power source” are shown in Diagram 2.2.1.

The inability to supply power attributable to the external power source, the inability to supply power using emergency diesel generators, the inability to interchange power sources, and the inability to restore power at an early stage have been cited as factors from an equipment and operational aspect as to the inability to supply AC power to the station.
