Examination of Accident at Tokyo Electric Power Co., Inc.'s Fukushima Daiichi Nuclear Power Station and Proposal of Countermeasures (Summary)

October 2011

Japan Nuclear Technology Institute Examination Committee on Accident at Fukushima Daiichi Nuclear Power Station

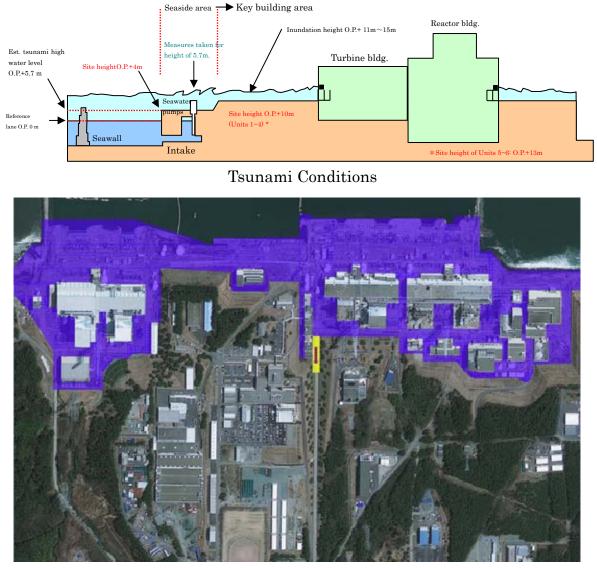
The height of the tsunami exceeded the water level designed for tsunami as shown in the diagram below, and almost the entire area around important buildings was inundated. Although there was no significant damage to the structural framework of key buildings, seawater flowed into the buildings through openings and other penetrations, and a broad expanse of the underground levels was also inundated through passageways, stairwells and other such routes.

In addition, many of the emergency DGs and electric power panels which were installed on the lower levels of the reactor and turbine buildings were damaged by tsunami. With the exception of Unit 6, functionality of emergency power sources was lost.

Moreover, all seawater pumps for cooling were damaged by tsunami, and any means of releasing heat from the core or other areas into the sea were lost. Important safety equipment also was damaged by seawater flooding into the buildings.

Scope of Inundation within Power Station (Purple area indicates seawater inundation and yellow area inidcates a run-up point)

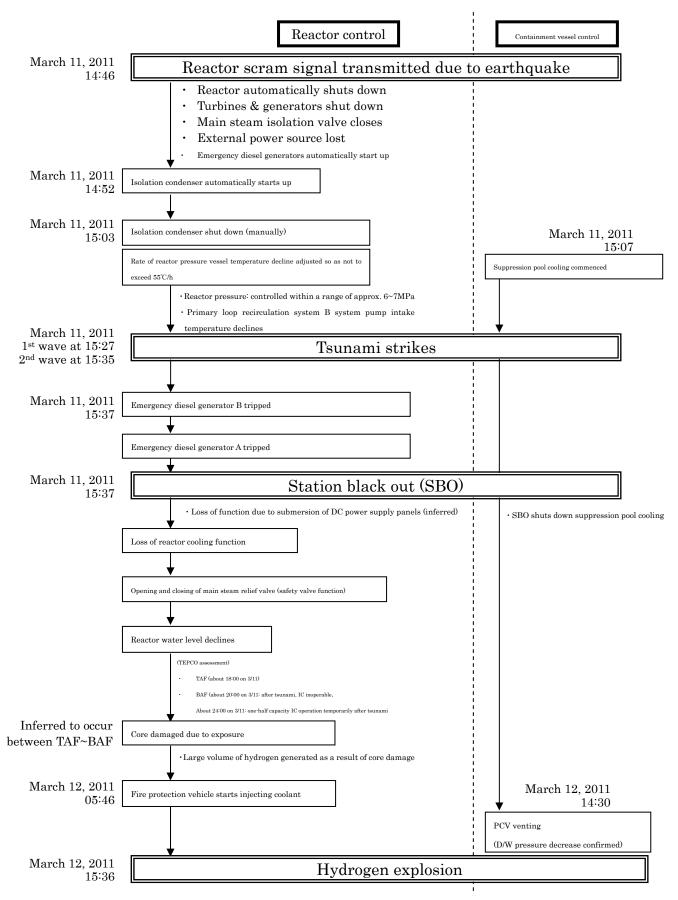
Diagram 2.1-1 Course of Accident Event Progression at Fukushima Daiichi Unit 1 Nuclear Power Station after Earthquake

The reactor at Unit 1 was cooled by the isolation condenser ("IC") in accordance with the shutdown procedures and guided into a cold shutdown, but the tsunami caused a loss of emergency AC and DC power source functionality, and it is possible that most of the valves were in a closed state.

Consequently, it is inferred that the core was not cooled, became damaged and hydrogen was generated which leaked from the containment vessel to the reactor building, leading to the hydrogen explosion.

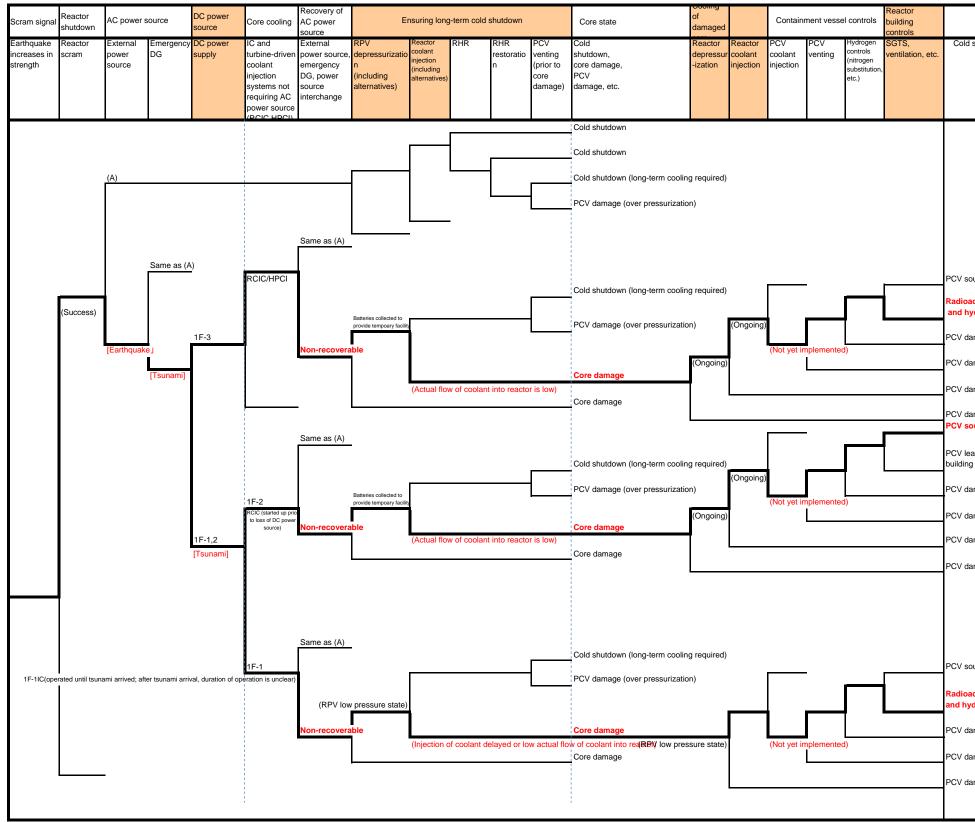
divaricating convergence and expansion of events have been arranged and consolidated into the event tree shown in Diagram 2.1-2.

The subsequent progression of events differs depending on (1) the circumstances entailed in loss of power source functions due to the earthquake and tsunami, (2) condition of core cooling function, and (3) success or failure of measures to mitigate events after core damage, as well as other factors.

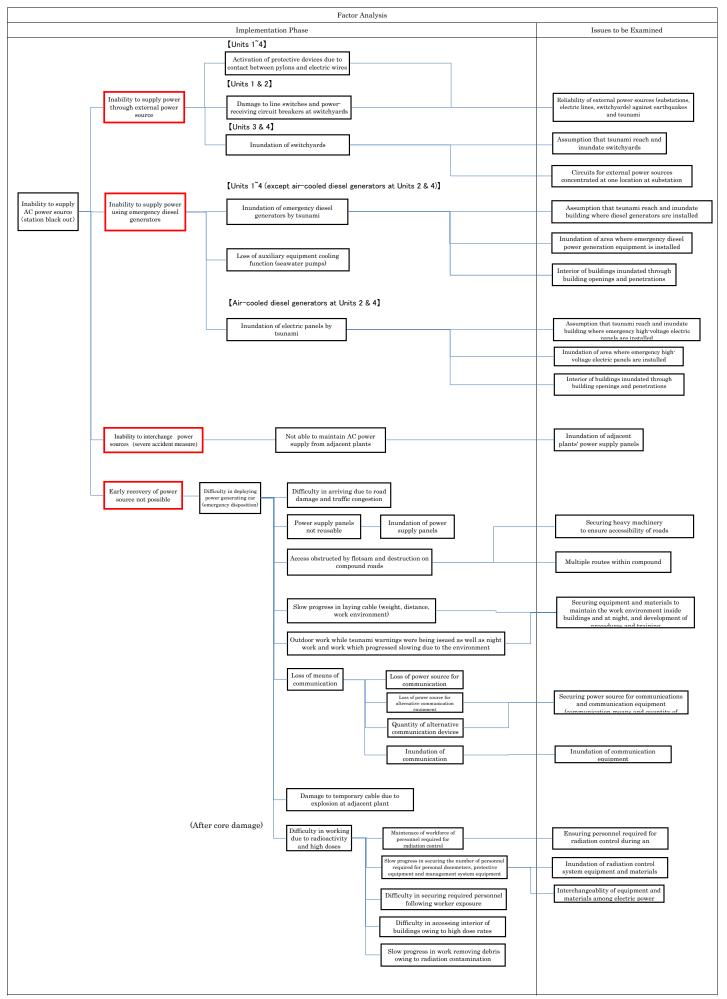
Diagram 2.2.1 Analysis of Factors Leading to Inability to Supply AC Power

The results of a factor analysis regarding the "inability to supply any AC power source" are shown in Diagram 2.2.1.

(1) Inability to Supply AC Power to the Station

The inability to supply power attributable to the external power source, the inability to supply power using emergency diesel generators, the inability to interchange power sources, and the inability to restore power at an early stage have been cited as factors from an equipment and operational aspect as to the inability to supply AC power to the station.
