# Facts about Earthquake at Kashiwazaki-Kariwa Nuclear Power Station in Japan

# Niigata-Chuetsu-Oki Earthquake in Japan

## Kashiwazaki-Kariwa Nuclear Power Station

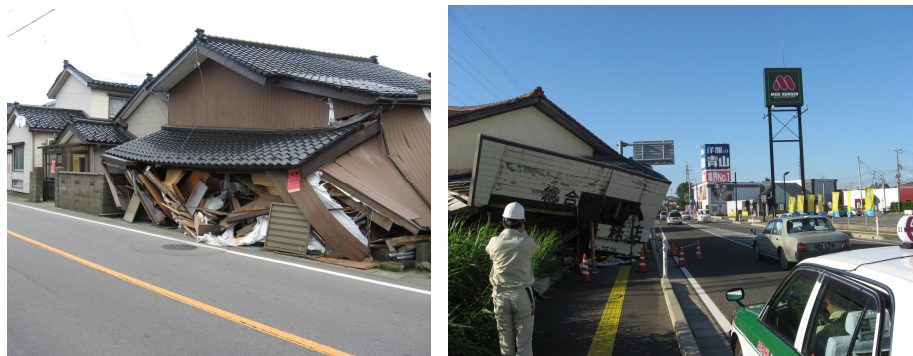
Some Old Wooden Houses were destroyed

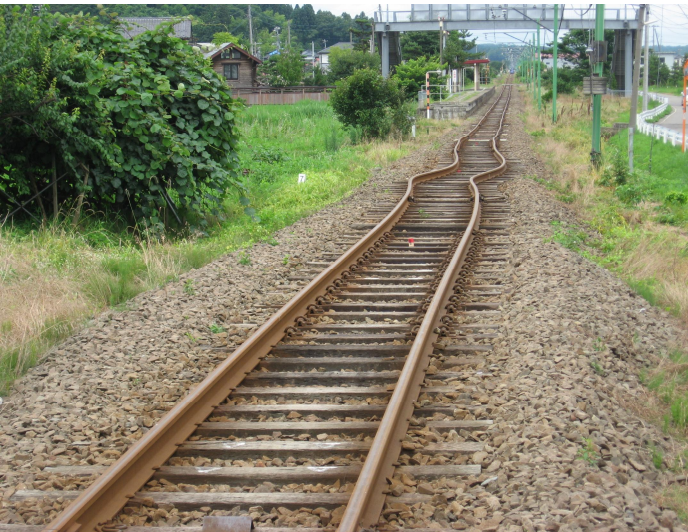
Railway was bent

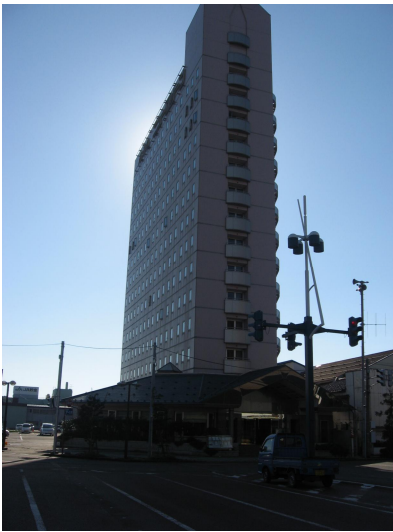
Few Concrete Building were damaged

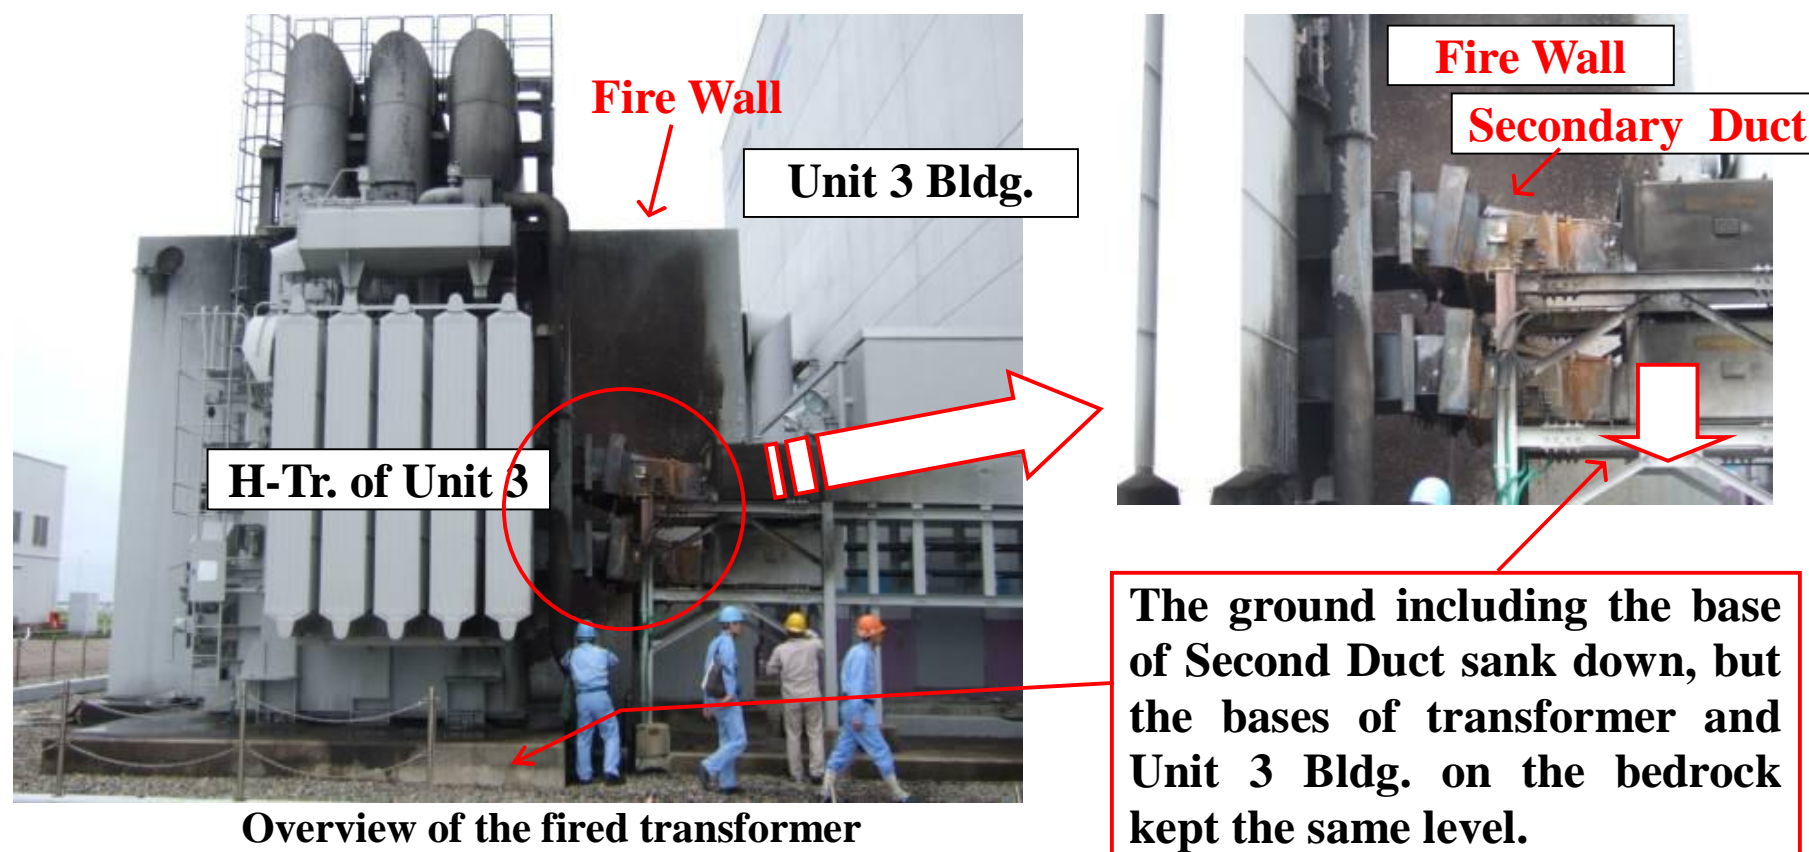
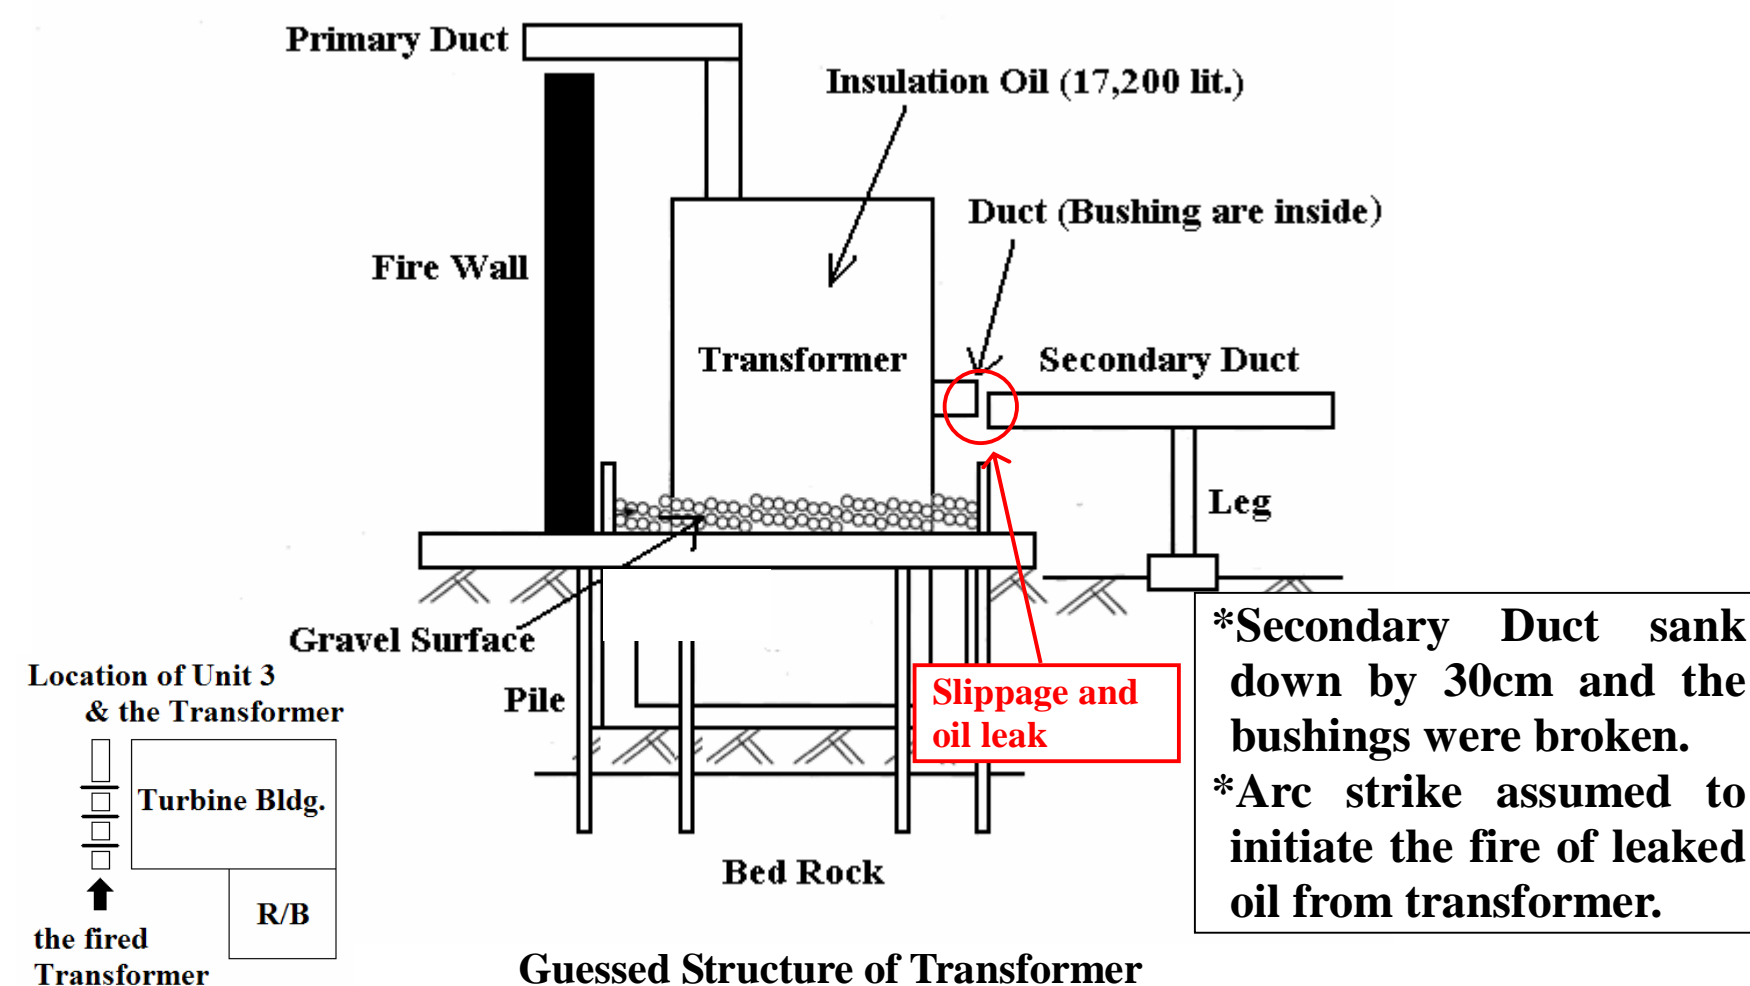
### A Fire on the House Transformer of Unit 3

- \*The House-Transformer (H-Tr.) of Unit 3 which supplies only non-safety-related SSCs with electricity was on fire after the earthquake.
- \*TEPCO's fire brigade hurried to the scene of the fire, but could not extinguish the fire because of the damage of fire protection piping.
- \*The fire was extinguished by the municipality fire brigade with fire engines 2 hours after it began.
- \*No damage appears in the Main-Transformer and the turbine building around the H-Tr. by fire walls and interspaces.

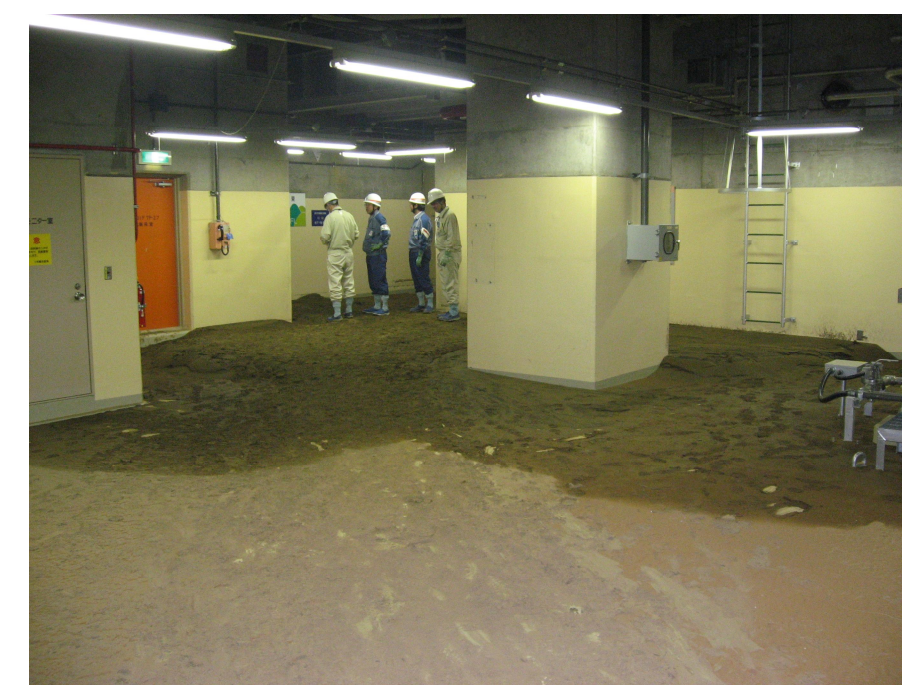
- \*The fire protection (FP) piping near the building of Unit 1 was damaged, and the FP water flowed into the Reactor Combination Building of Unit 1.
- \*Approximately 2,000m<sup>3</sup> FP water accumulated at the bottom floor.
- \*Many of equipment for the waste disposal are installed on the bottom floor of the Reactor Combination Building. However, it seemed that the flood didn't submerge the safety-related equipments such as Emergency Core Cooling System (ECCS) of the Reactor Building.

Mud accumulated on the floor under the inflow hole

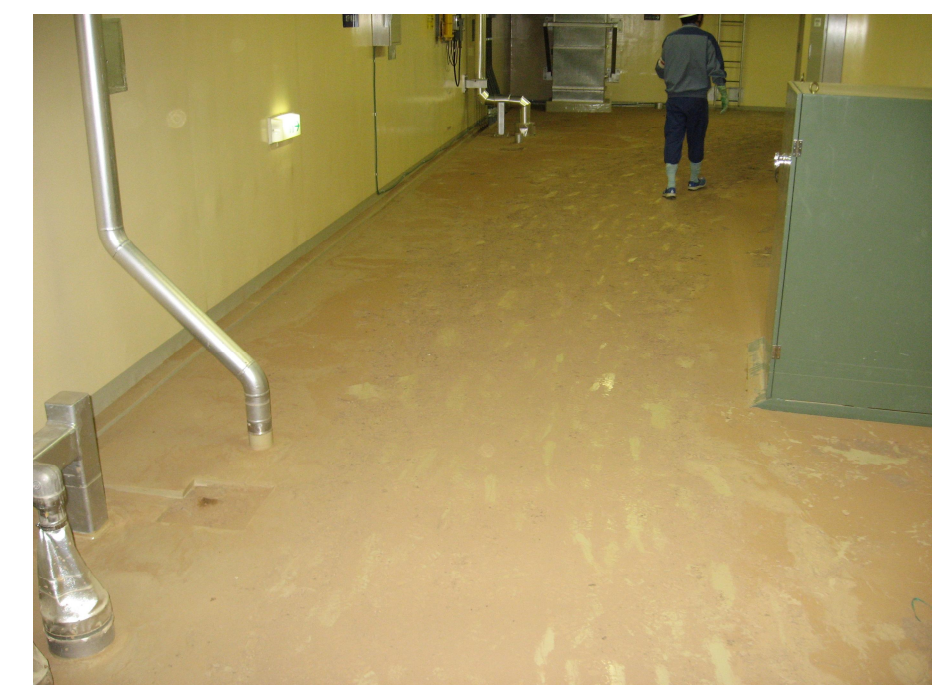
Fine sand covered over the floor after FP water flowed

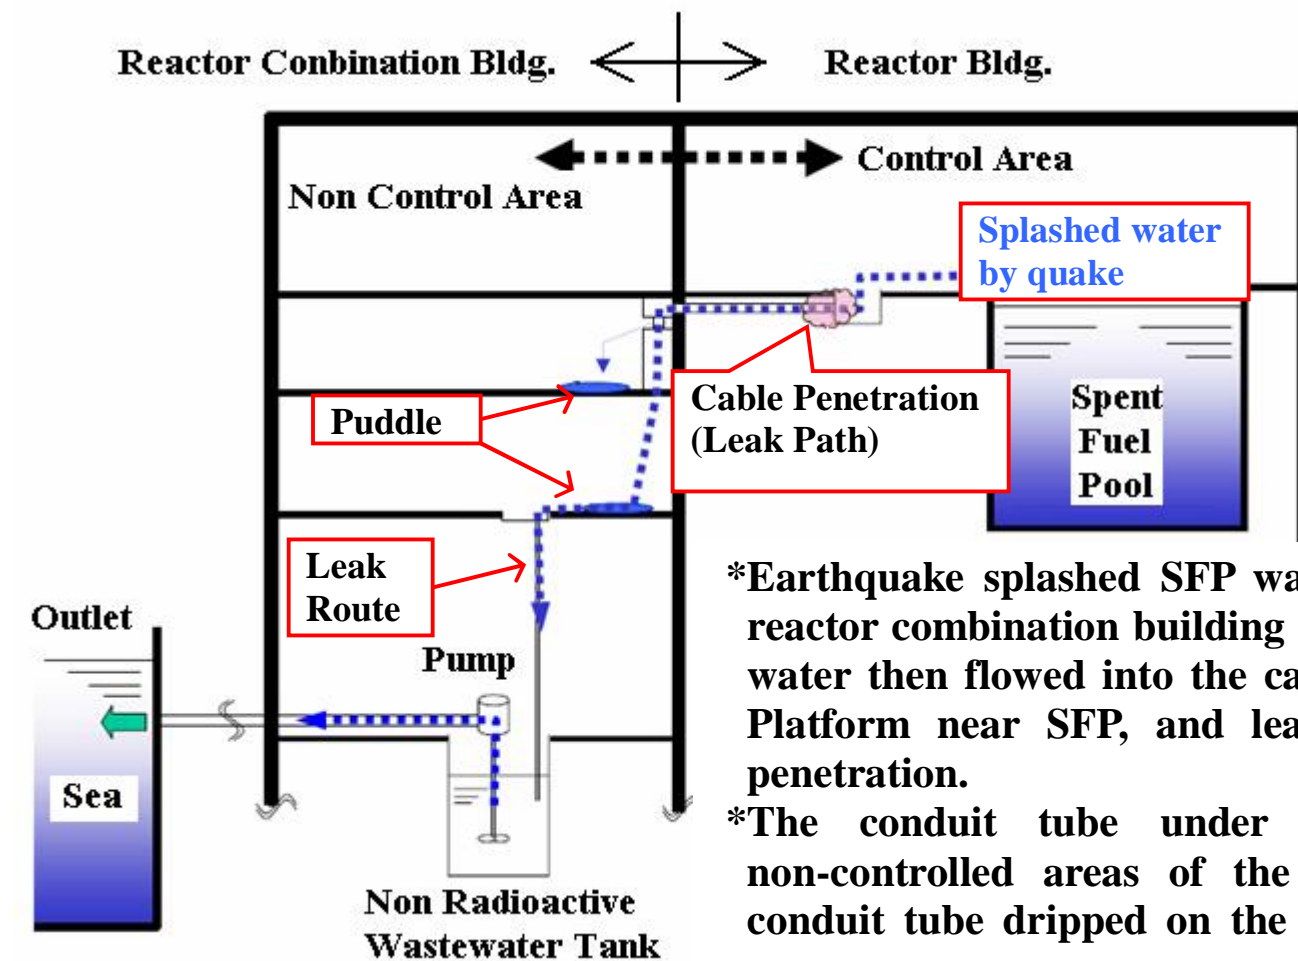
\*Earthquake splashed SFP water on the operation floor of the reactor combination building (radiological controlled area). The water then flowed into the cable junction box of the Refueling Platform near SFP, and leaked into the path of the cable penetration.

\*The conduit tube under the operating floor, leads to non-controlled areas of the building. Leaked water of the conduit tube dripped on the lower floor of the non-controlled area.

\*The puddles on the floor flowed into the non-radioactive wastewater tank along the drain, and pumped out into the sea.

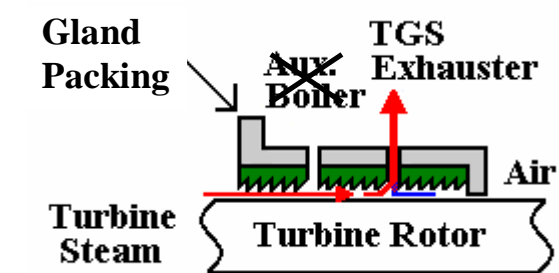
Fig 2. In This Incident

- \*The cause of the leakage is believed delay of the stop of the TGS exhauster after automatic reactor shutdown.
- \*The TGS exhauster normally exhausts supplied TGS (blue line of Fig 1). But in this incident, TGS exhauster was continuously in operation, though TGS was stopped to supply.
- \*It is suspected that the iodine and radioactive gas in the turbine, were blown out by the TGS exhauster (red line of Fig 2), and released into the atmosphere through the stack.
