Company name	Kansai EPCO
Date of occurrence	25.September.2007
Unit name	Mihama 2
Event	Flaws Found in Steam Generator A Reactor Coolant Inlet Nozzle Weld
International Nuclear Event Scale (INES)	0
Status of report	Final report

# Status of Mihama Unit 2 planned outage (Cause and Countermeasures of the Flaw in Steam Generator A Reactor Coolant Inlet Nozzle Weld portion)

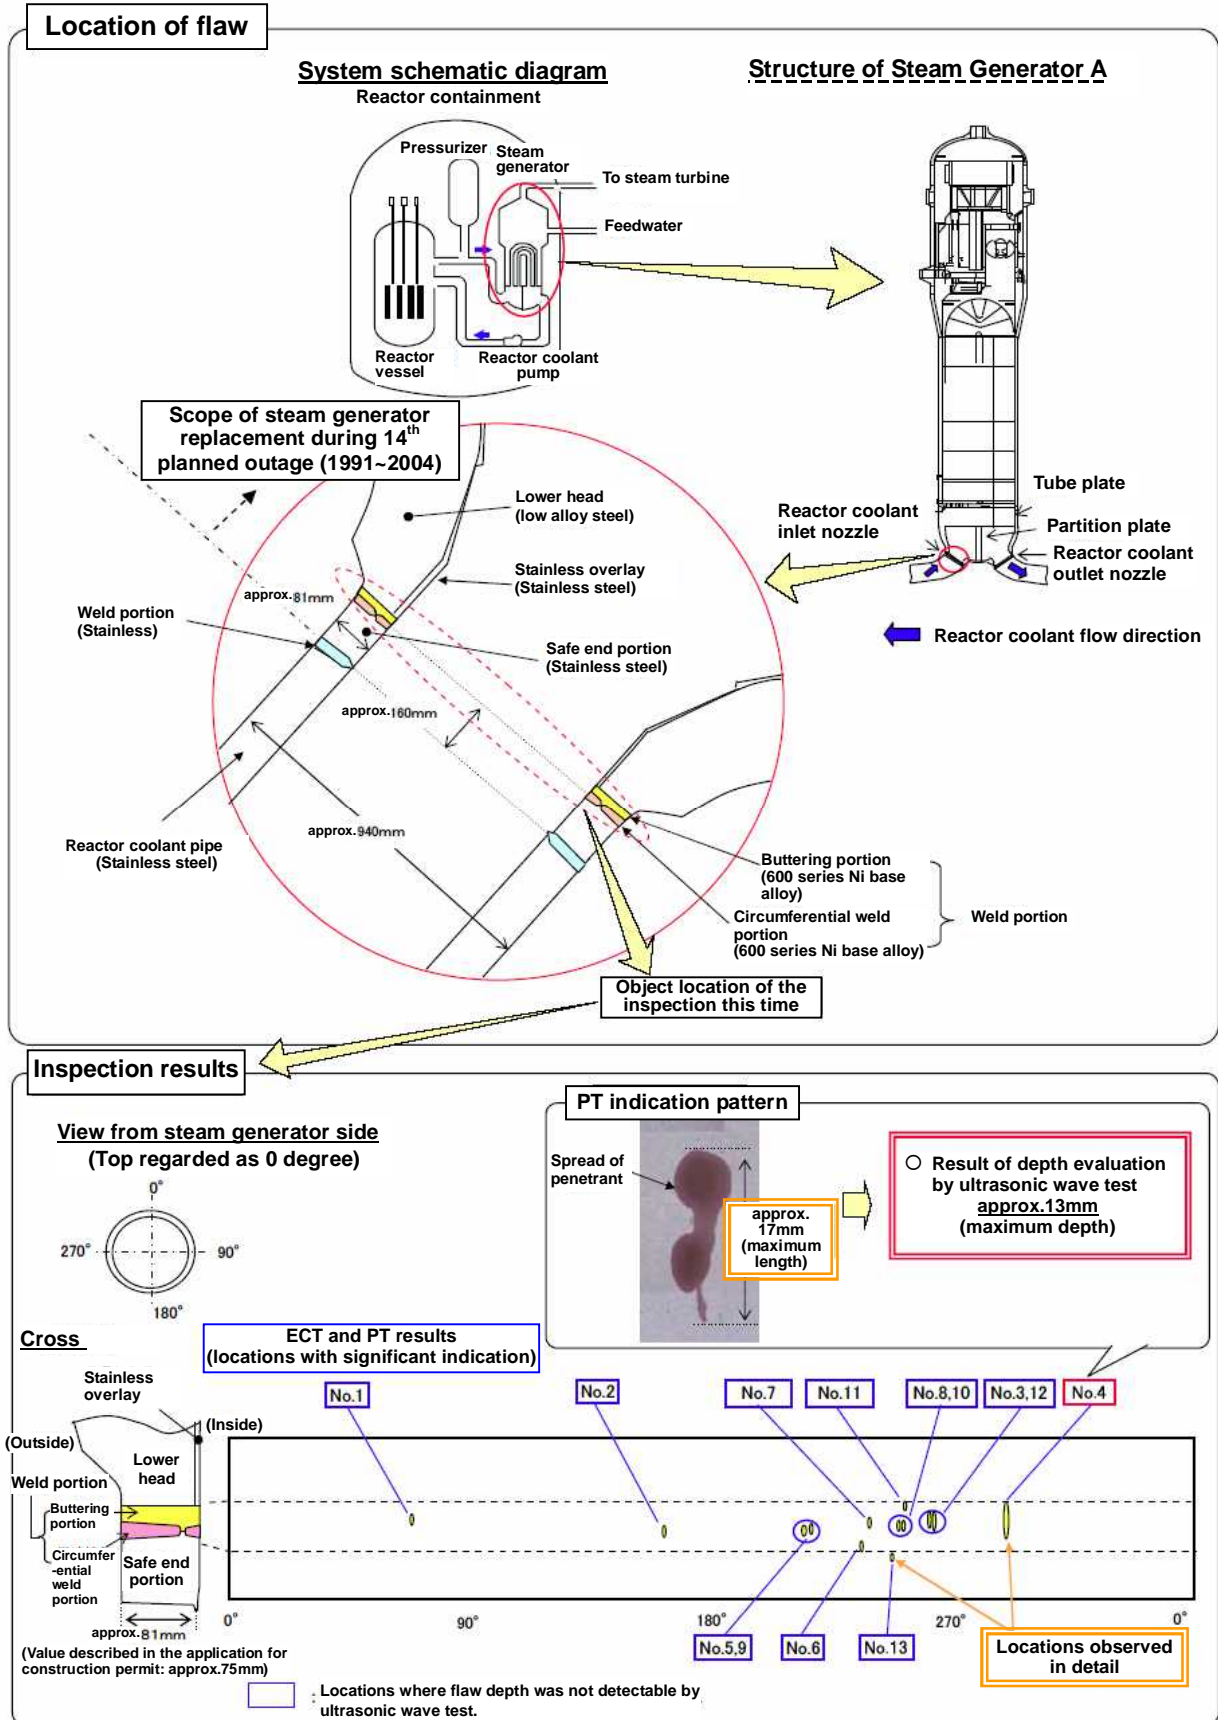
During manufacturing of replacement of the S/G, after welding the inlet nozzle and the safe end using 600 series Ni base alloy weld metal, machining was performed, and thereby a hardness increase and a high residual stress in a very thin surface layer on the inner surface nearby the safe end weld were caused.

Although the cracking initiation point was not identified, intergranular cracking nearby the weld is considered to have developed due to stress during operation etc.

### Observation results for the weld portion

- Multiple cracks of approx. 3 to 5 mm length existed intermittently in longitudinal direction.
- Cracking was along dendrite boundary in the weld portion.

### Fracture observation

- Trace of machining was found.

- Multiple cracking was found with branching along grain boundary of metal crystal.

The portion cut out will be recovered using 690 series Ni base alloy weld which has better corrosion resistivity. In addition, for caution's sake, a buffing finish will be applied in order to reduce residual stress in the affected portion.

The safe end portion (SUS316 base metal) will be replaced with a new one and finished with buffing. Further, a study on cracking generation in the safe end will be performed to enhance relevant knowledge.
