| Company name | Kyushu EPCO |
| Unit name | Genkai 1 |
| Event | Inspection of the Inner Surfaces of Welded Locations of the Primary Coolant Outlet and Inlet Nozzles of Steam Generators |
| Status of report | Final report |

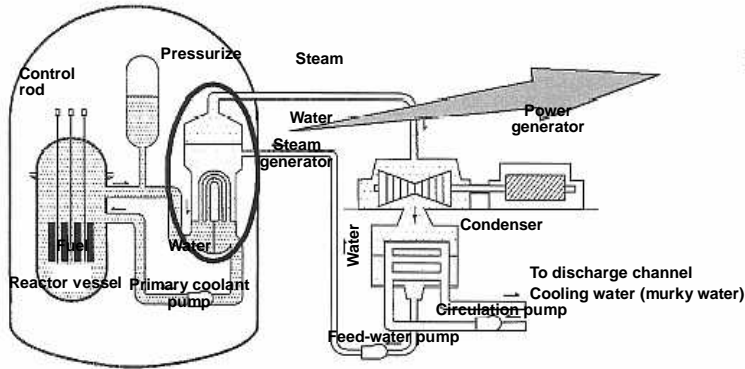
Schematic System Illustration

General chart of inlet nozzle of steam generator of Genkai Nuclear Power Plant Unit 1

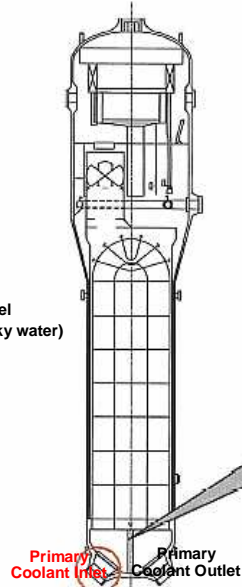
Schematic Illustration of A Steam Generator

| <p>1. Inspection results</p> <p>(1) ECT result</p> <p>Significant signal indication was found in the axial direction at three locations of the welded locations of the inlet nozzle of A-SG; locations at 9 degrees in circumferential direction (No.1), at 130 degrees (No.2) and 344 degrees (No.3). (Circumferential direction angle is measured setting the starting point (0 degrees) at the highest point of the nozzle, then going around clockwise viewing the nozzle from the water chamber.)</p> <p>(2) UT result</p> <p>UT was conducted for the parts showing significant signal indications in ECT of the welded locations of the inlet nozzle of A-SG. However, no significant signal indication was found nor was it estimated that the</p> | |

Angle measured in clockwise direction at 0° by seeing nozzle from water chamber

As for locations where significant signal indication was found in ECT, grinding was performed until no significant signal indication was found in ECT for the depth investigation and, furthermore, an additional grinding was conducted considering the investigation accuracy of ECT.
