Company name	Japan Atomic Power Company
Date of occurrence	18.October.2007
Unit name	Tsuruga 2
Event	Flaws Identified in the Steam Generator Reactor Coolant Inlet Nozzle Welds
International Nuclear Event Scale (INES)	0
Status of report	Final report

**Periodic inspection status at Tsuruga Unit 2  
(The cause and countermeasures of the flaws in the steam generator reactor coolant inlet nozzle welds)**

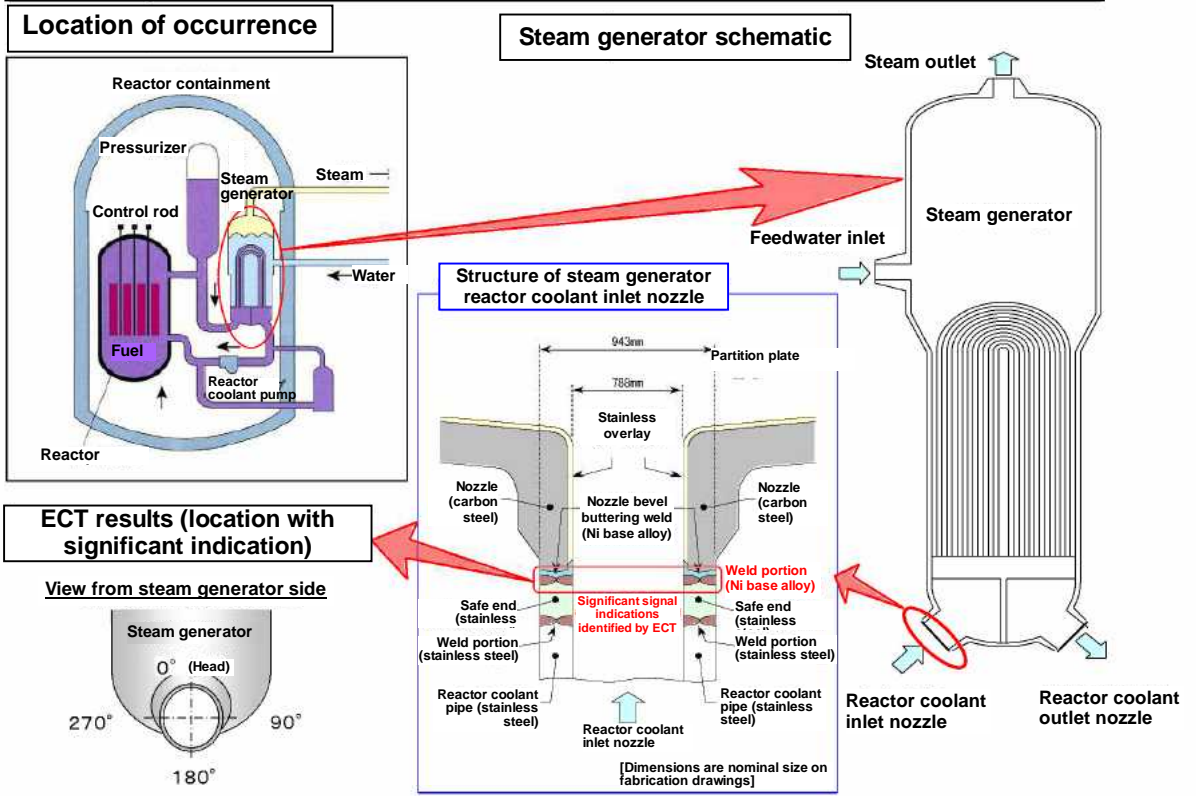
**ECT results (location with significant indication)**

The rough surface (fine flaws) and cracking identified in the inlet nozzle weld portion of steam generator A, B and C were all along the dendrite boundary and they were verified to exhibit PWSCC aspects.

From the above, these cracking and rough surface (fine flaws) was considered to be due to PWSCC.

View from steam generator side

- (1) The circumferential weld portion inner surface will be machined for entire circumference in order to remove shallow cracking, and then deeper cracking will be removed by grinder.
- (2) Subsequently, for the area where deeper cracking was removed, buildup welding with 600 series Ni base alloy will be performed. Then, on the circumferential weld portion inner surface entire circumference machined to remove shallow cracking, buildup welding will be performed using 690 series Ni base alloy which has a better corrosion resistivity.

(3) For the sake of caution, from the view point of reducing residual stress in the area where buildup welding was performed with 690 series Ni base alloy, buff finishing will be performed for the area. Also, for steam generator A of which circumferential weld portion was identified to have rough surface (fine flaws), removal of the rough surface will be performed based on considerations for the structural strength of the portion, the function of stainless lining material (inner surface buildup portion) of the inlet nozzle inner surface and its inspectability for the eddy current test from the inner surface side. Then, the residual stress in the weld portion surface will be reduced by shotpeening etc.
