Company name	Hokkaido EPCO
Date of occurrence	April 9, 2008
Unit name	Tomari 2
Event	Confirmation of Flaws at Welded Part of Primary Coolant Inlet Nozzle of Steam Generator A and B
International Nuclear Event Scale (INES)	0
Status of report	Final report

## The Periodic Inspection Status of Tomari NPP Unit 2 Cause and Countermeasures for Flaws at Welded Part of Primary Coolant Inlet Nozzle of Steam Generator

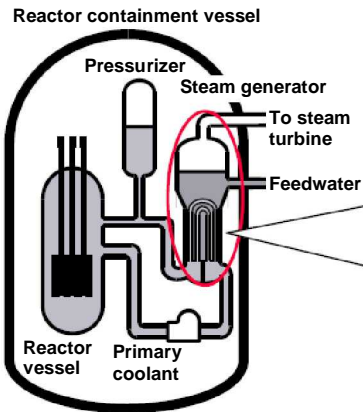
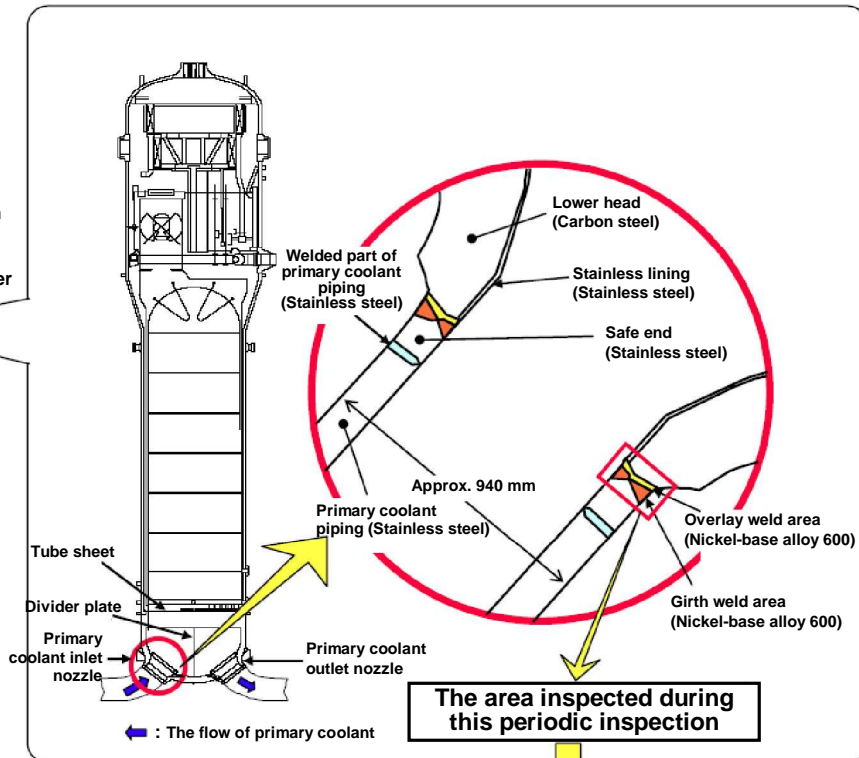
### Place of occurrence

Ultrasonic test\*2 (hereinafter referred to as "UT") was conducted at areas where significant signals were indicated with ECT and significant signals that can evaluate the depth of the flaw were indicated at one place in SG-A and SG-B respectively.

Depths of the flaws were evaluated as approx. 7 mm and 5 mm in SG-A and SG-B respectively. The plate thicknesses of the two areas which were subtracted the depths of the flaws from the plate thicknesses of the relevant parts of approx. 78 mm, SG-A approx. 71 mm and SG-B approx. 73 mm, were judged below the value of the application for construction plan approval of 75 mm stipulated by the Electricity Utilities Industry Law.

e. From the results above, as similar to that of Tsuruga NPP Unit 2, there is a possibility that PWSCC have occurred at Tomari NPP Unit 2 also due to high tensile residual stress at the inner surface where traces of grinding work (grinding) and buff finishing grinding work (grinding) were remained and at the inner surface where grinding work (polishing) at the repair welding location was performed.

1. The whole circumference of the inner surface of SG inlet nozzle welded part shall be cut by a cutting device and after the shallow cracks are removed, deeper cracks shall be removed partially by grinding work (grinding) as necessary. PT shall be used to confirm the removal of cracks, etc.
2. After the removal, overlay welding shall be performed using 600 type nickel base alloy as for areas where deep cracks are removed and another overlay welding shall be performed throughout the whole circumference of the inner surface of the welded part using 690 type nickel base alloy, which is superior in corrosion resistivity as a recovery measure. As a precautionary measure, buffing work shall be performed on areas in concern to reduce residual stress.
