# Facts about Earthquake at Kashiwazaki-Kariwa Nuclear Power Station in Japan

# Niigata-Chuetsu-Oki Earthquake in Japan

## Kashiwazaki-Kariwa Nuclear Power Station

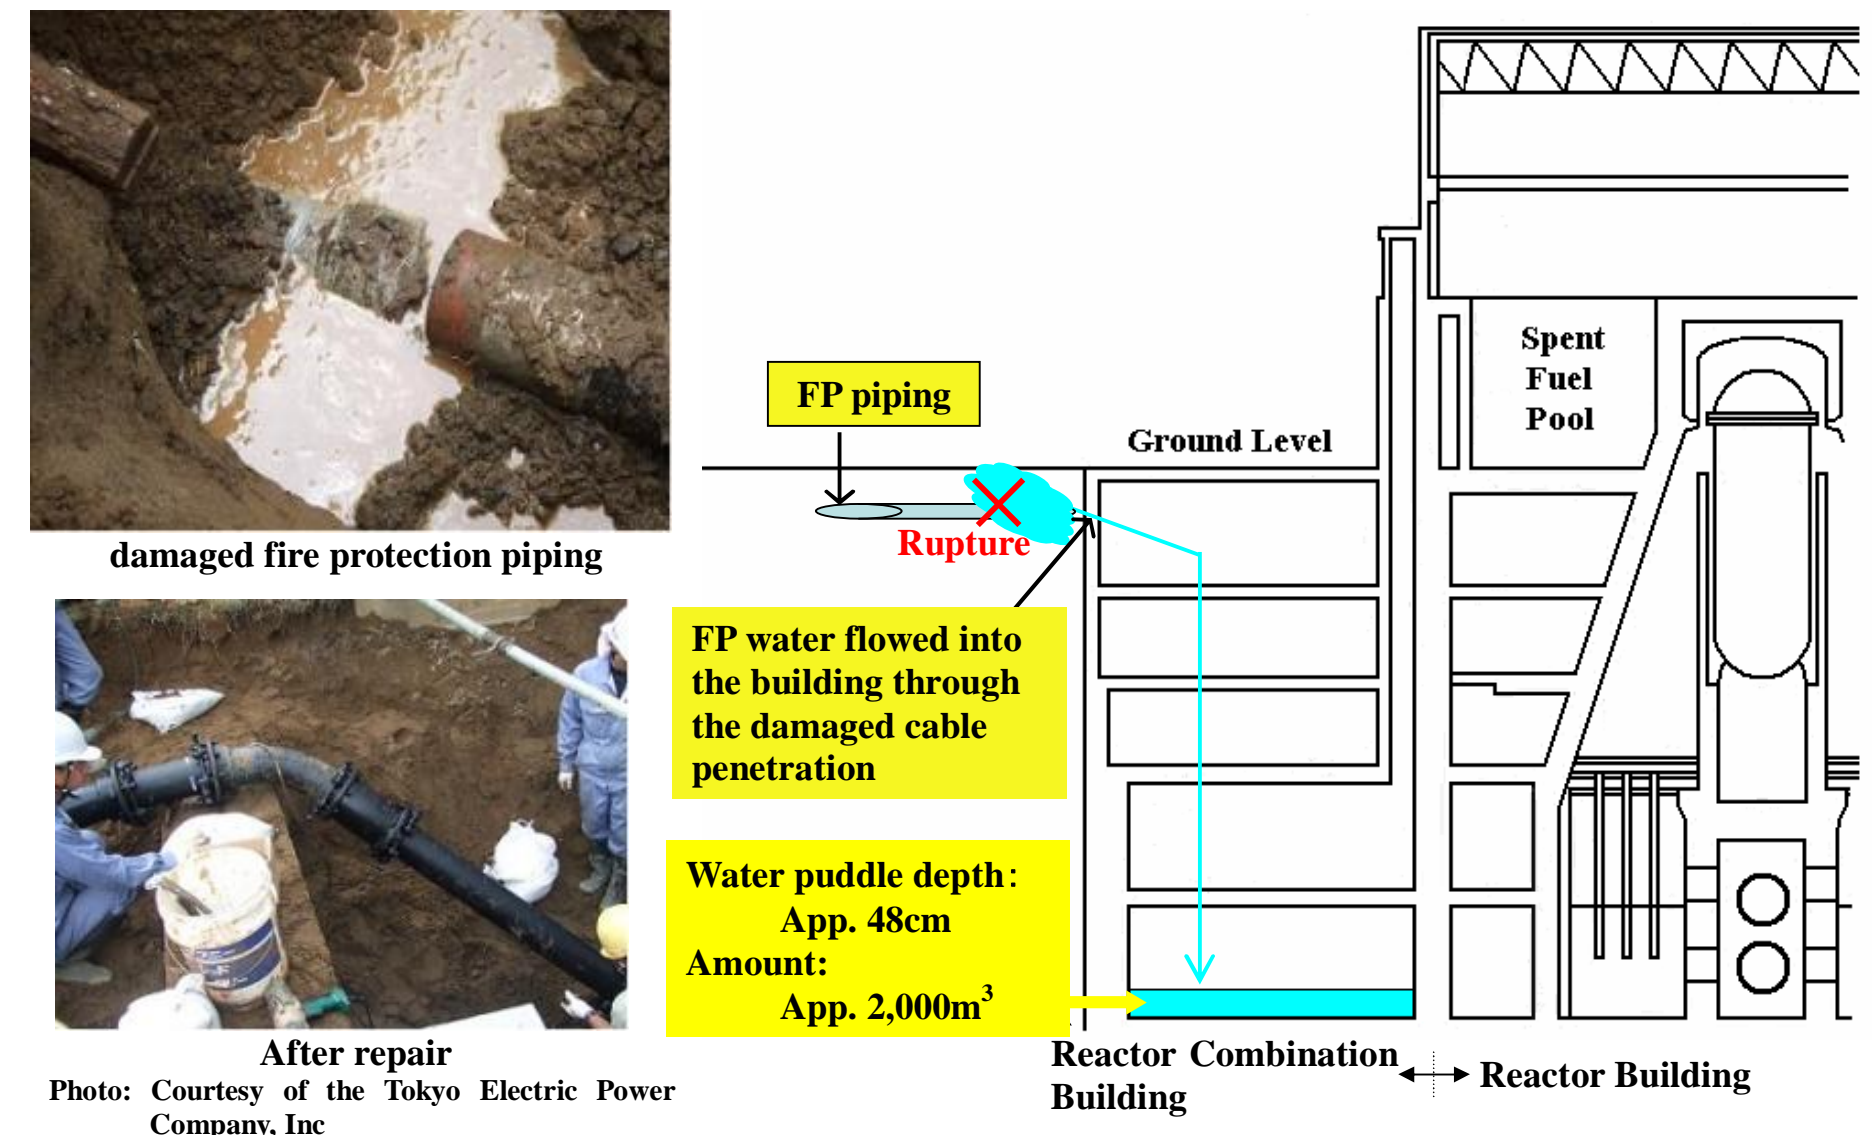
- \*The fire protection (FP) piping near the building of Unit 1 was damaged, and the FP water flowed into the Reactor Combination Building of Unit 1.
- \*Approximately 2,000m<sup>3</sup> FP water accumulated at the bottom floor.
- \*Many of equipment for the waste disposal are installed on the bottom floor of the Reactor Combination Building. However, it seemed that the flood didn't submerge the safety-related equipments such as Emergency Core Cooling System (ECCS) of the Reactor Building.

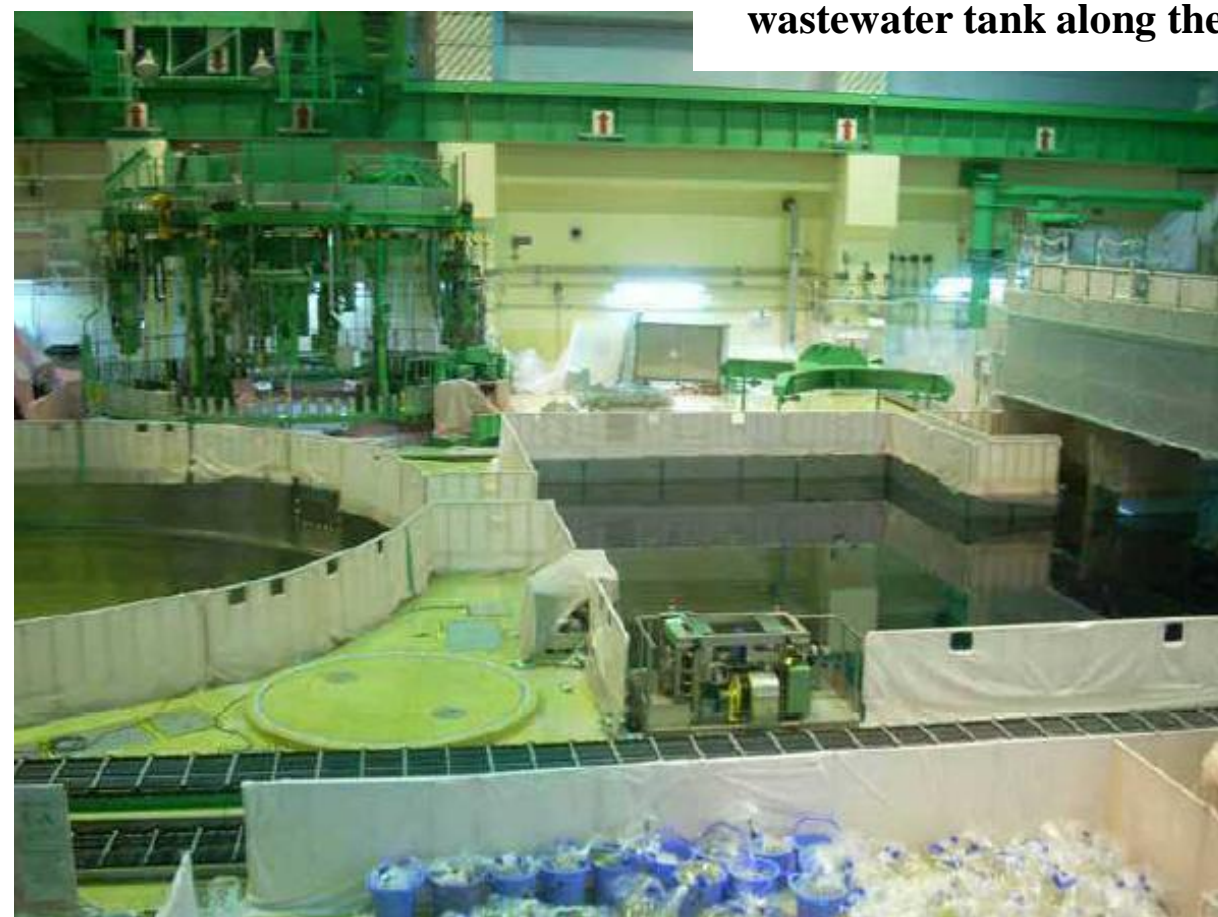
Overview of Operating Floor

\*Earthquake splashed SFP water on the operation floor of the reactor combination building (radiological controlled area). The water then flowed into the cable junction box of the Refueling Platform near SFP, and leaked into the path of the cable penetration.

\*The conduit tube under the operating floor, leads to non-controlled areas of the building. Leaked water of the conduit tube dripped on the lower floor of the non-controlled area.

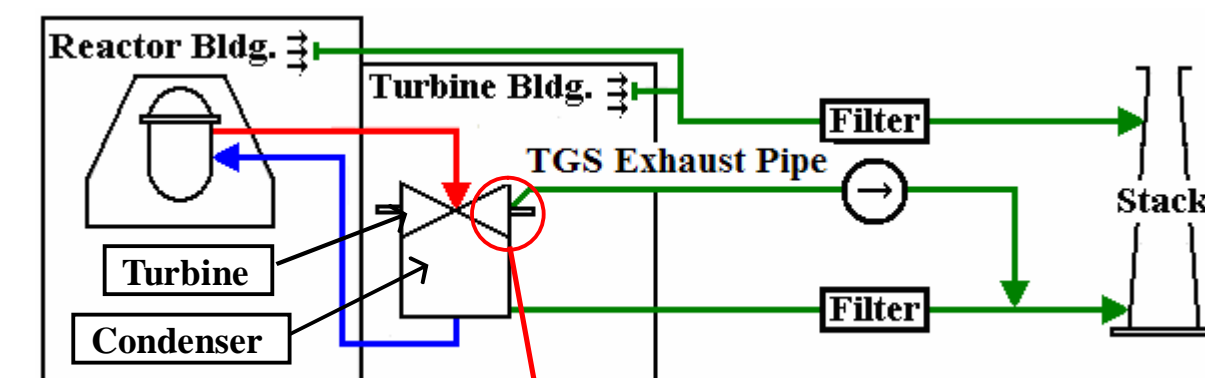
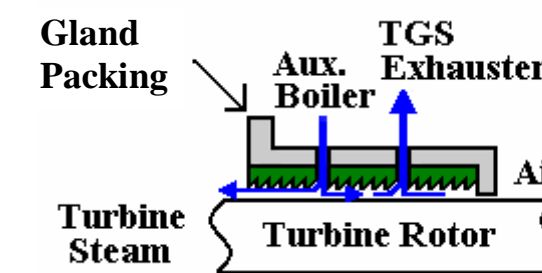
Fig 1. In Normal Operation

- \*The cause of the leakage is believed delay of the stop of the TGS exhauster after automatic reactor shutdown.
- \*The TGS exhauster normally exhausts supplied TGS (blue line of Fig 1). But in this incident, TGS exhauster was continuously in operation, though TGS was stopped to supply.
- \*It is suspected that the iodine and radioactive gas in the turbine, were blown out by the TGS exhauster (red line of Fig 2), and released into the atmosphere through the stack.
